Wear mechanisms of silicon carbide-whisker-reinforced alumina (Al₂O₃-SiCw) cutting tools when high-speed machining aged Alloy 718

Bushlya, Volodymyr; Zhou, Jinming; Avdovic, Pajazit; Ståhl, Jan-Eric

Published in:
International Journal of Advanced Manufacturing Technology

2013

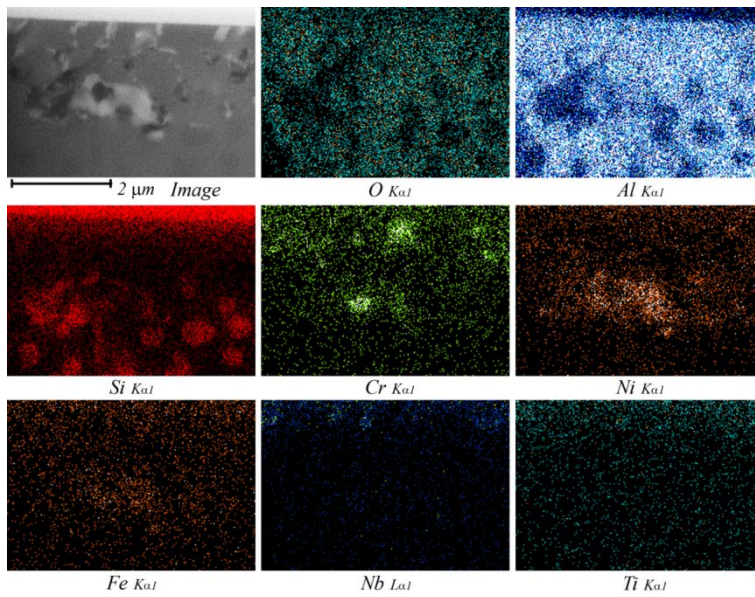
EDX mapping (see Fig. 8) on a lamellae removed from the rake of worn-out insert via focused ion beam (FIB) milling allowed to identify diffusion of Ni, Cr, Fe and to some extent Nb into SiC whiskers while no diffusional attack on alumina was evident. Previously reported diffusion of Ti [17], Mo and Co [24] was not observed. It can be seen that silicon is not present in a near-surface region which can be explained by counterdiffusion of silicon and Alloy 718 with replacement by diffusing elements. It is also noted that Ni and Fe diffuse markedly deeper than Cr (Fig. 8) due to an ease of formation of chromium carbides with free carbon left in the whiskers after replacement of Si. Intensive carbide-formation tendency of niobium can be similarly attributed to its limited diffusion into the near-surface region.

Fig. 8 EDX map of diffusion of elements from Alloy 718 into the tool material
