## Design of Safe Timber Structures - How Can we Learn from Structural Failures in Concrete, Steel and Timber?

Frühwald, Eva; Serrano, Erik; Toratti, Tomi; Emilsson, Arne; Thelandersson, Sven

Report TVBK-3053  
Lund 2007

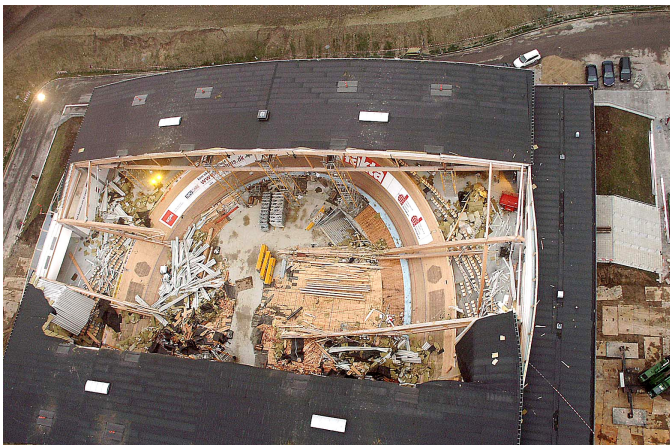
*Fig. 2. Photo taken from above after the failure of the Ballerup arena roof.*

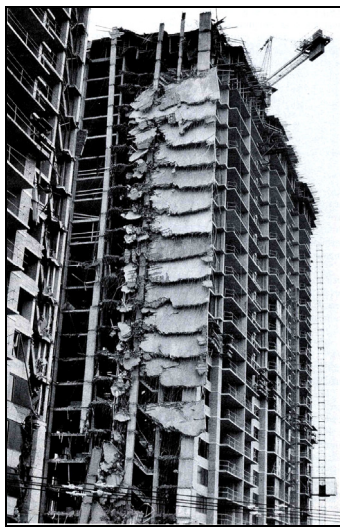
Damage related to work execution includes inadequate vibration, placement of reinforcement in wrong position, deformation of formwork, inadequate curing conditions of the concrete after casting etc. Furthermore, damage during construction may occur due to premature removal of shoring, too weak shoring, insufficient lateral bracing of shores etc., see also [27] and [28]. An example of catastrophic failure due to premature removal of shoring is shown in Fig. 4. Failure of the supporting system during casting lead to a progressive collapse initiated by punching shear failure in a flat slab. The collapse caused the death of fourteen construction workers.

*Fig. 4. Progressive failure of multi-storey concrete building due to premature removal of shoring, 1973, Virginia, USA.*

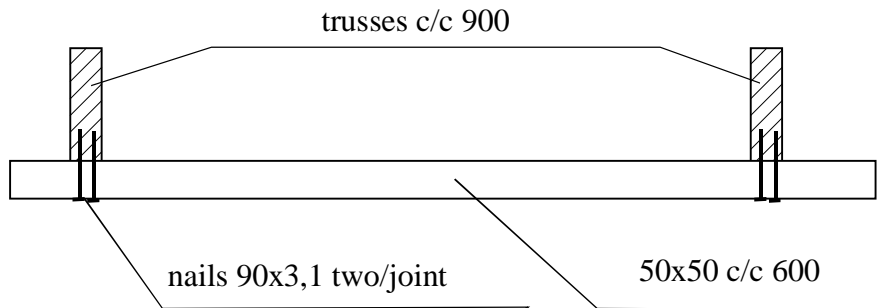
*Figure 11. Support connection for ceiling in supermarket.*

withdrawal capacity of the nails fastening the 50 x 50 mm<sup>2</sup> wood battens for the ceiling to the bottom chord of the roof truss. The designer had prescribed three nails in each joint, but only two were provided during construction. One reason for this was that the designer did not realise that there was not enough space – as given in relevant standards – for three nails in the contact surface between the battens and the bottom chord of the truss. In this case the failure was classified as 0.5 (50 %) due to poor manufacturing principles and 0.5 (50 %) due to design error. In cases where only one cause was identified, the weight for this error type was set to 1.0. With this method the sum of all error types over all cases will equal 127, and the corresponding percentages can be calculated.

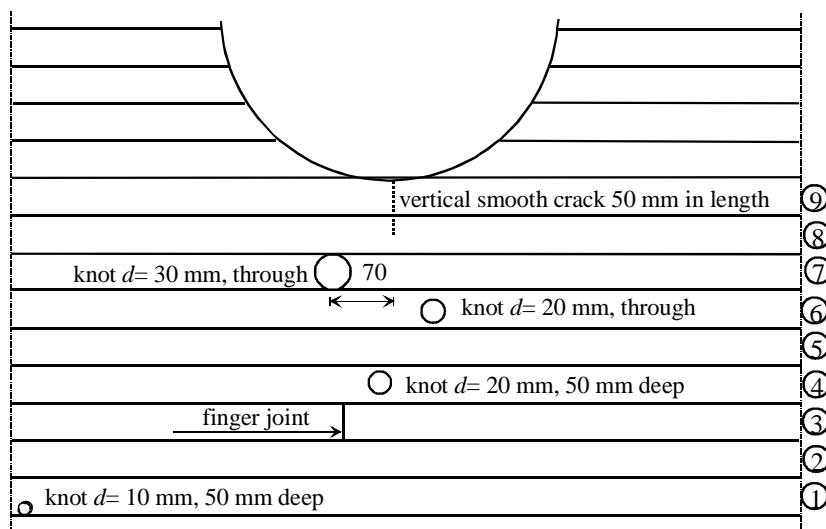
Figure 79-1: Part of fractured beam.

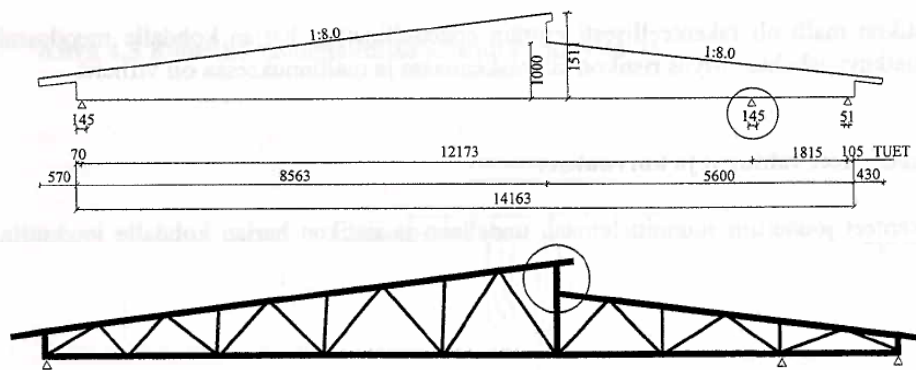
The truss members were not properly placed (discontinuity in mid-span), see figure 89-1. The top chord is not aligned causing a high bending load on the vertical member.

Figure 89-1: The top chord is not aligned at centre span causing a high bending load on the vertical member.

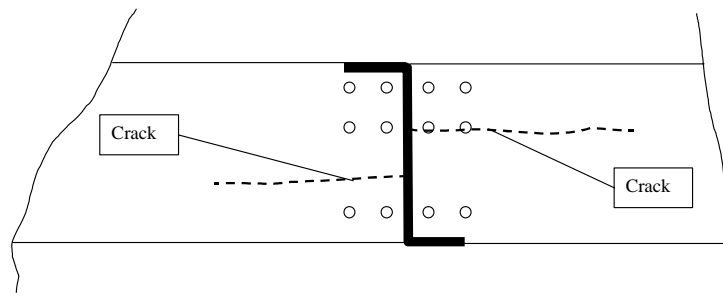
Figure 109-2. Schematic of beam connection and cracks found.

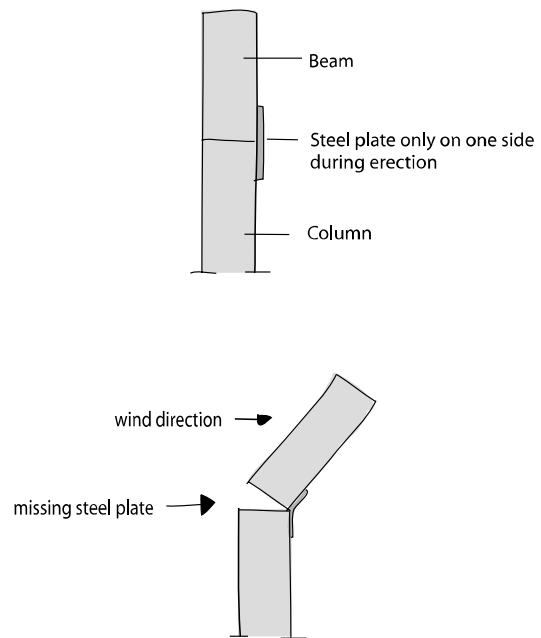
*Figure 125-2: Joint between columns and beams. Left: joint as executed, right: failed joint.*
