## Sediment Sampling and Analysis in Rönne å at Ängelholm

Inamdeen, Fainaz; Larson, Magnus

2021

Water Resources Engineering  
Report 3243  
ISSN 1101-9824

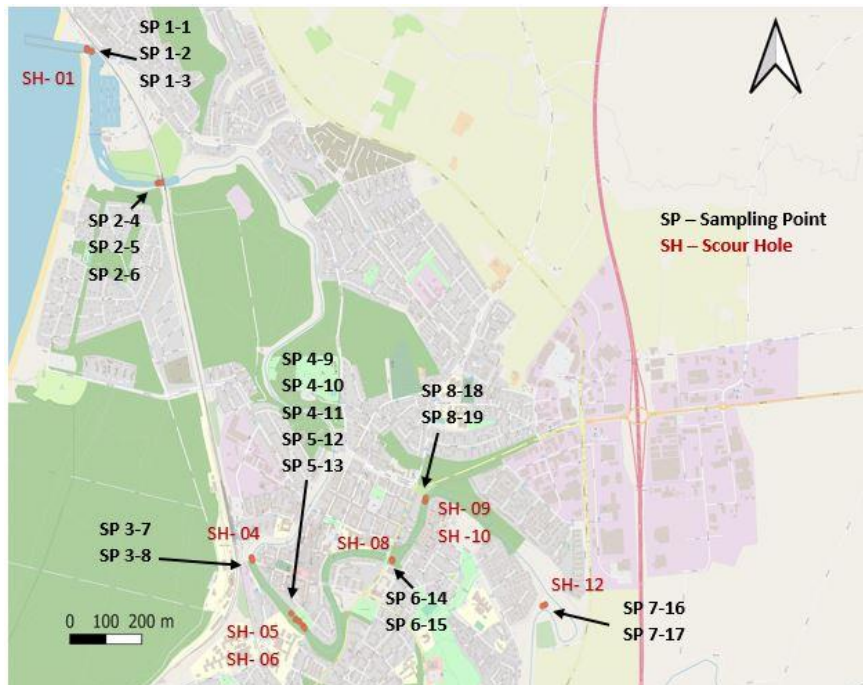
Figure 1. Overview map of the sample locations. SH denotes major scour holes identified in Inamdeen (2020) that were the basis for selecting sample locations.

Overall, the sampling and related analysis verified the hypotheses about the mechanisms governing the evolution of the scour holes at the investigated locations. The main causes of the scour were bend scour (locations SH1, SH4, SH9, SH10, and, SH12; see figure 1), bridge scour (SH8), and hard bottom scour (SH5 and SH6). However, at SH8, SH9, and SH10, hard bottom also contributed to the scour. The sediment parameters determined in the grain-size analysis will be useful for calculating the development and equilibrium properties of the scour holes using appropriate formulas from the literature. For the samples where grain-size analysis could be carried out the median grain size approximately varied between 0.6 mm and 15 mm, but larger-sized substrate (*e.g.*, gravel) was observed in the field at hard bottom locations, where no samples could be retrieved by the applied sampling technique.

The main causes of the scour at the different holes, confirmed by the present sampling, were bend scour (SH1, SH4, SH9, SH10, and, SH12), bridge scour (SH8), and hard bottom scour (SH5 and SH6). However, at SH8, SH9, and SH10, hard bottom also contributed to the scour.

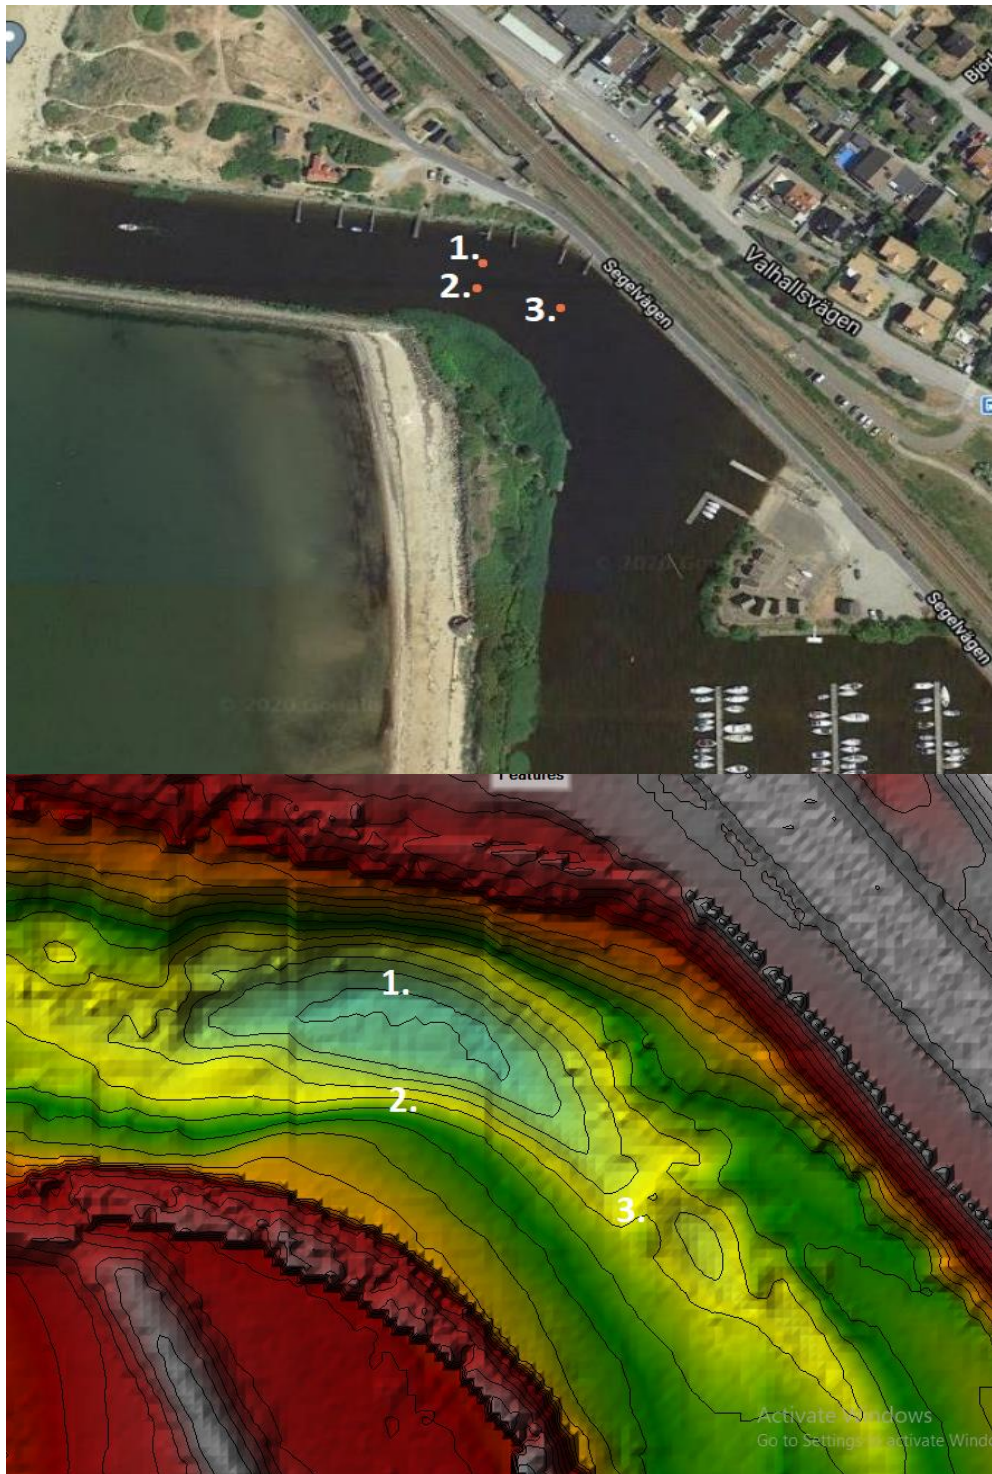
*Figure 2. Location 1 with sample points 1 to 3*

| Location | Sample points | X-Coordinate | Y-Coordinate | Remarks |
|---|---|---|---|---|
| Location 1: KP 0 + 425 m | 1 | 366124.8657 | 6238420.42 | Center of hole SH-01 |
| | 2 | 366122.3797 | 6238409.299 | Left side of hole SH-01, where some sediment accumulation was expected |
| | 3 | 366156.137 | 6238398.832 | Upstream of hole SH-01, where sedimentation could occur due to pool-riffle sequences in bend |

The sample 1-2 was taken adjacent to a bend scour hole (2.0 m deeper than the normal river bottom), near the river outlet to Skälderviken. This location represents an inner curve of a bend where sedimentation normally takes place (see figure 2). The sample textural group may be characterized as slightly gravelly sand.

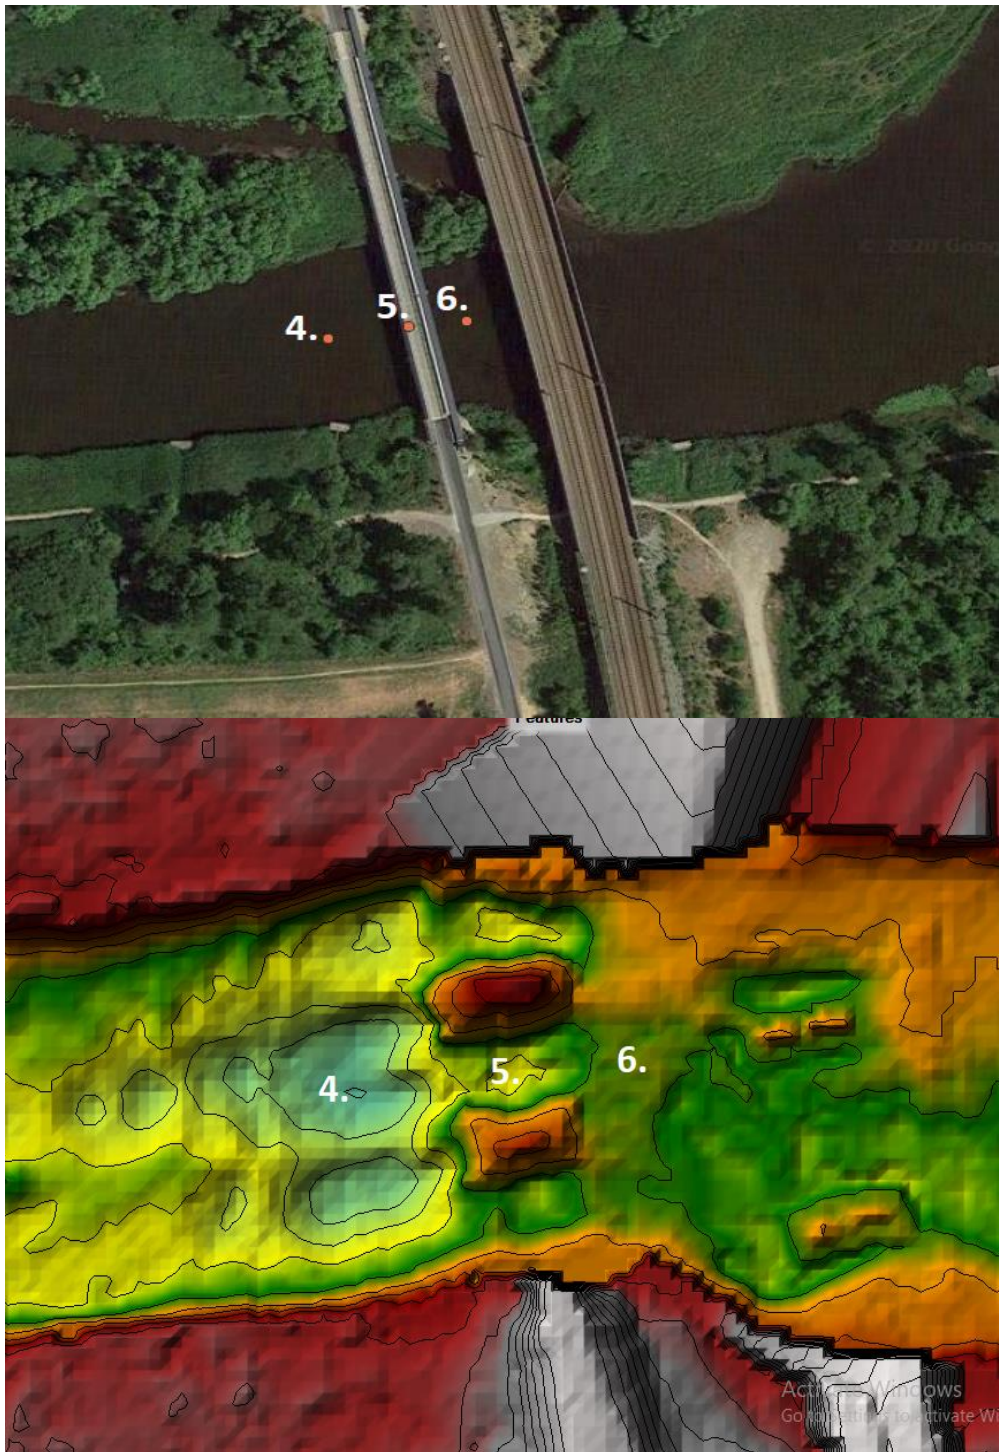
*Figure 3. Location 2 with sample points 4 to 6*

| Location | Sample points | X-Coordinate | Y-Coordinate | Remarks |
|---|---|---|---|---|
| Location 2: KP 1 + 575 m | 4 | 366578.06 | 6237589.413 | In the wake zone of Flygarebron; possibility for bridge scouring |
| | 5 | 366594.0933 | 6237591.607 | In between piers of Flygarebron |
| | 6 | 366605.5394 | 6237592.561 | Approach section (upstream) of Flygarebron |

The sample 2-6 was taken from the approach section to Flygarebron (upstream) and downstream of the Skälderviken bron (see figure 3). The sample contained larger rock pieces suggesting an armored or hard bottom. The sample analysis was performed by visually means due to the sample characteristics and the quantity of material obtained.

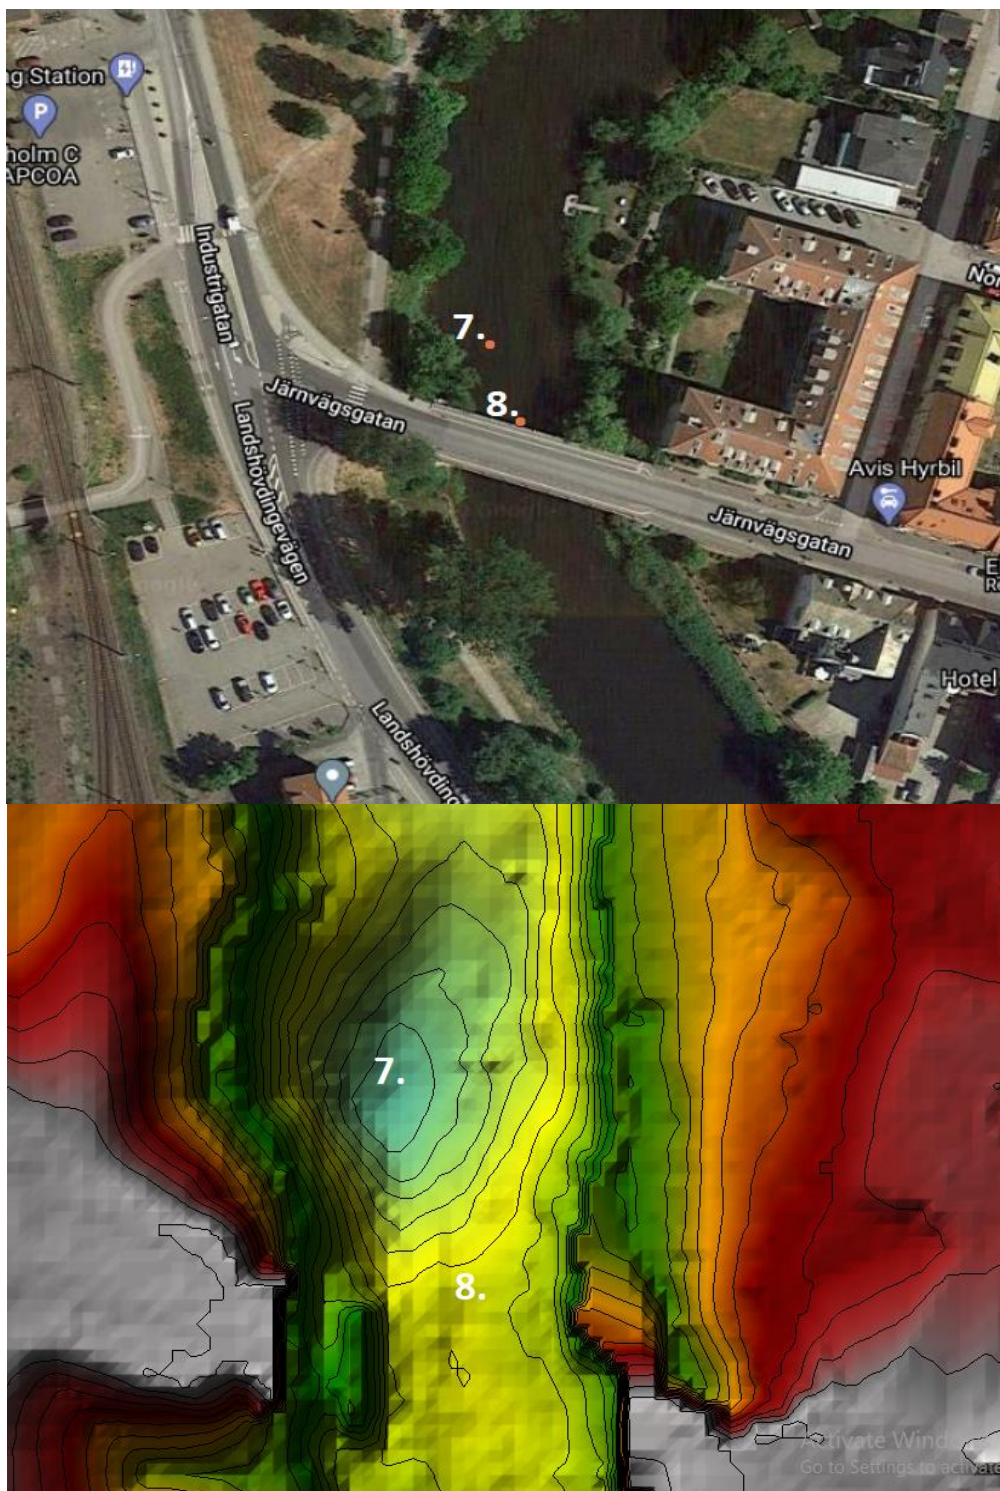
*Figure 4. Location 3 with sample points 7 and 8*

| Location | Sample points | X-Coordinate | Y-Coordinate | Remarks |
|---|---|---|---|---|
| Location 3: KP 5 + 600 m | 7 | 367145.6507 | 6235307.131 | Center of hole SH-04 (downstream) of Järnvägsbron |
| | 8 | 367151.0876 | 6235290.439 | Upstream of hole SH-04, just downstream of Järnvägsbron |

The sample 3-7 was taken from the center part of a scour hole near Järnvägsbron (see figure 4). The sample contained mussels and were not subjected to sieve analysis. The sample textural group is characterized as gravel.

The sample 3-8 was taken upstream of a scour hole (2.0 m deeper than the normal river bottom), downstream Järnvägsbron (see figure 4). The sample contained larger rock pieces, which suggested hard bottom. The sample analysis was performed visually because of the sample characteristics and obtained quantity of material.

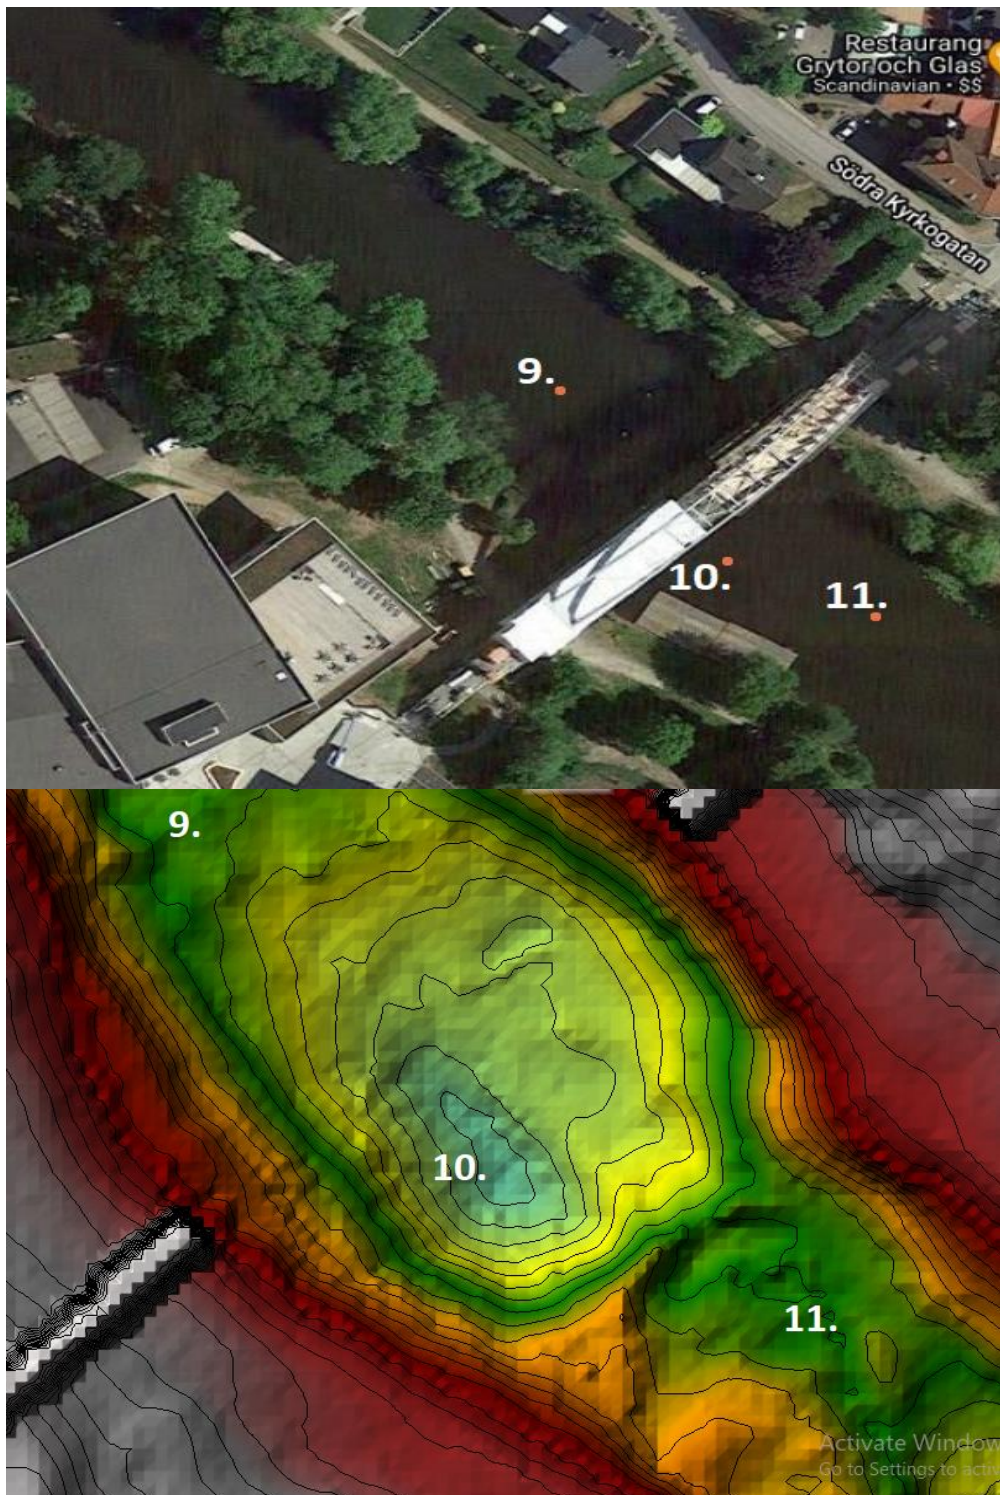
*Figure 5. Location 4 with sample points 9 to 11*

| Location | Sample points | X-Coordinate | Y-Coordinate | Remarks |
|---|---|---|---|---|
| Location 4: KP 6 + 025 m | 9 | 367405.0904 | 6234961.6 | Downstream of hole SH-05 (at Tullportsbron) |
| | 10 | 367432.6458 | 6234924.977 | Center of hole SH-05 (at Tullportsbron) |
| | 11 | 367457.6105 | 6234912.613 | Upstream of hole SH-05 (at Tullportsbron) and downstream of hole SH-06 |

The sample 4-9 was taken in the downstream part of a scour hole (3.5 m deeper than the normal river bottom), near Tullportsbron (see figure 5). The sample textural group is characterized as gravelly sand. The sample was mixed with lots of mussels, as seen in pictures below.

The sample 4-10 was taken from center part of a scour hole (3.5 m deeper than the normal river bottom), under Tullportsbron (see figure 5). The sample textural group is characterized as sandy gravel.

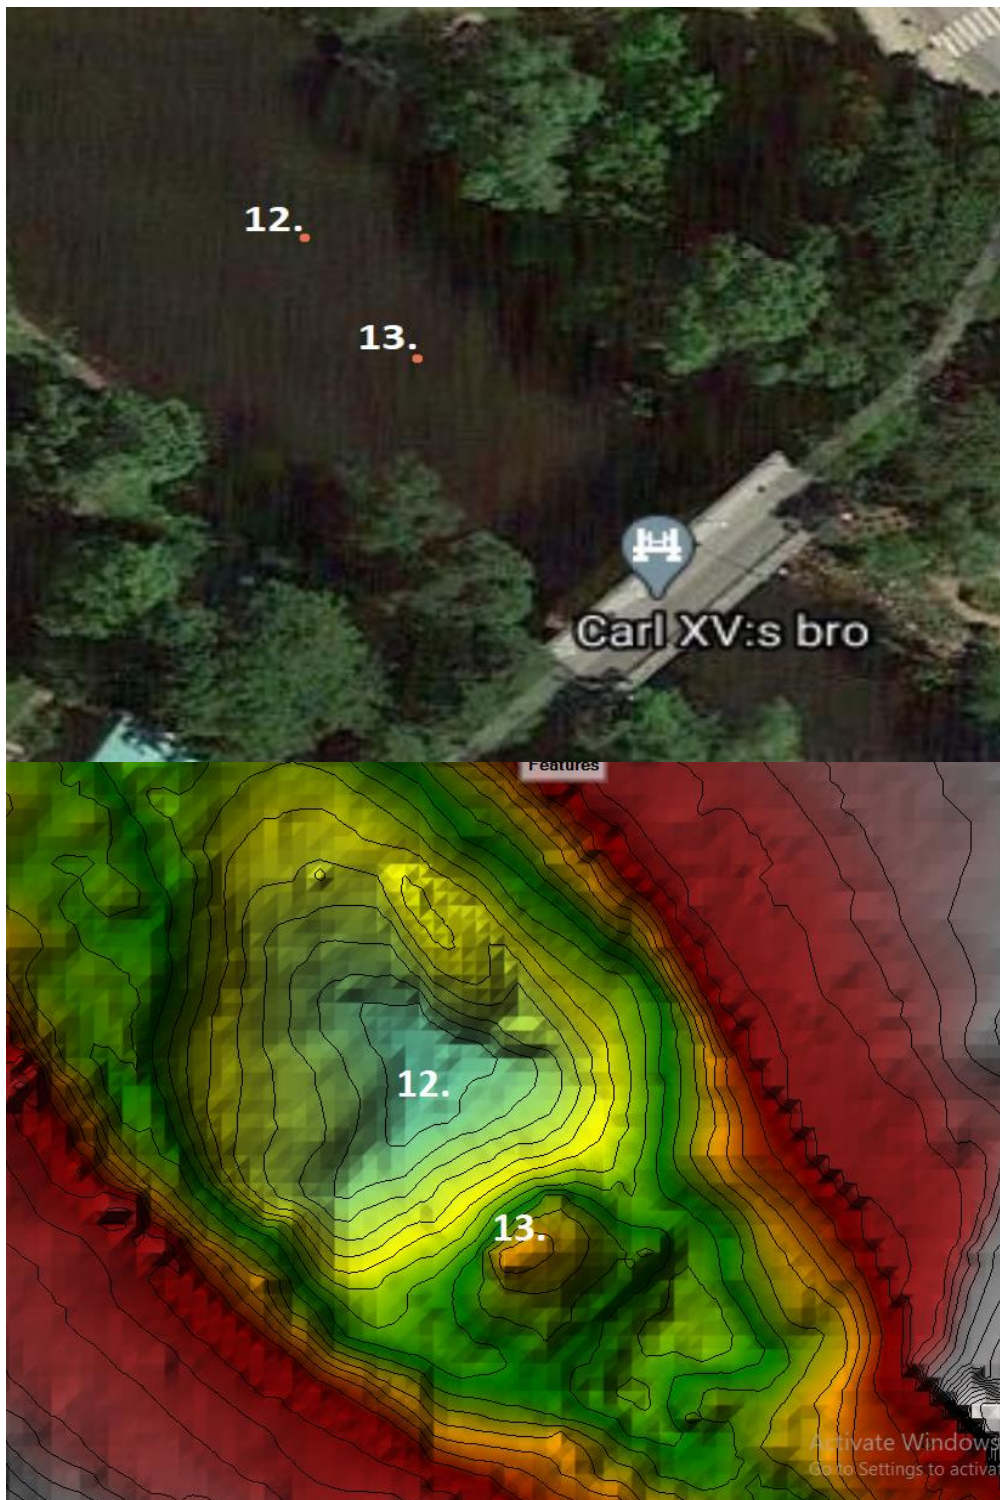
*Figure 6. Location 5 with sample points 12 and 13*

| Location | Sample points | X-Coordinate | Y-Coordinate | Remarks |
|---|---|---|---|---|
| Location 5: KP 6 + 175 m | 12 | 367483.0753 | 6234882.952 | Center of hole SH-06 (at Carl XV bron) |
| | 13 | 367493.0334 | 6234869.303 | Upstream of hole SH-06 (at Carl XV bron), where hard bottom is expected |

The sample 5-12 was taken from the center part of a scour hole (3.5 m deeper than the normal river bottom), near Carl XV bridge (see figure 6). The sample analysis was performed visually due to the sample characteristics and sample quantity. The sample suggests that the particular bottom is hard and contains larger rock particles.

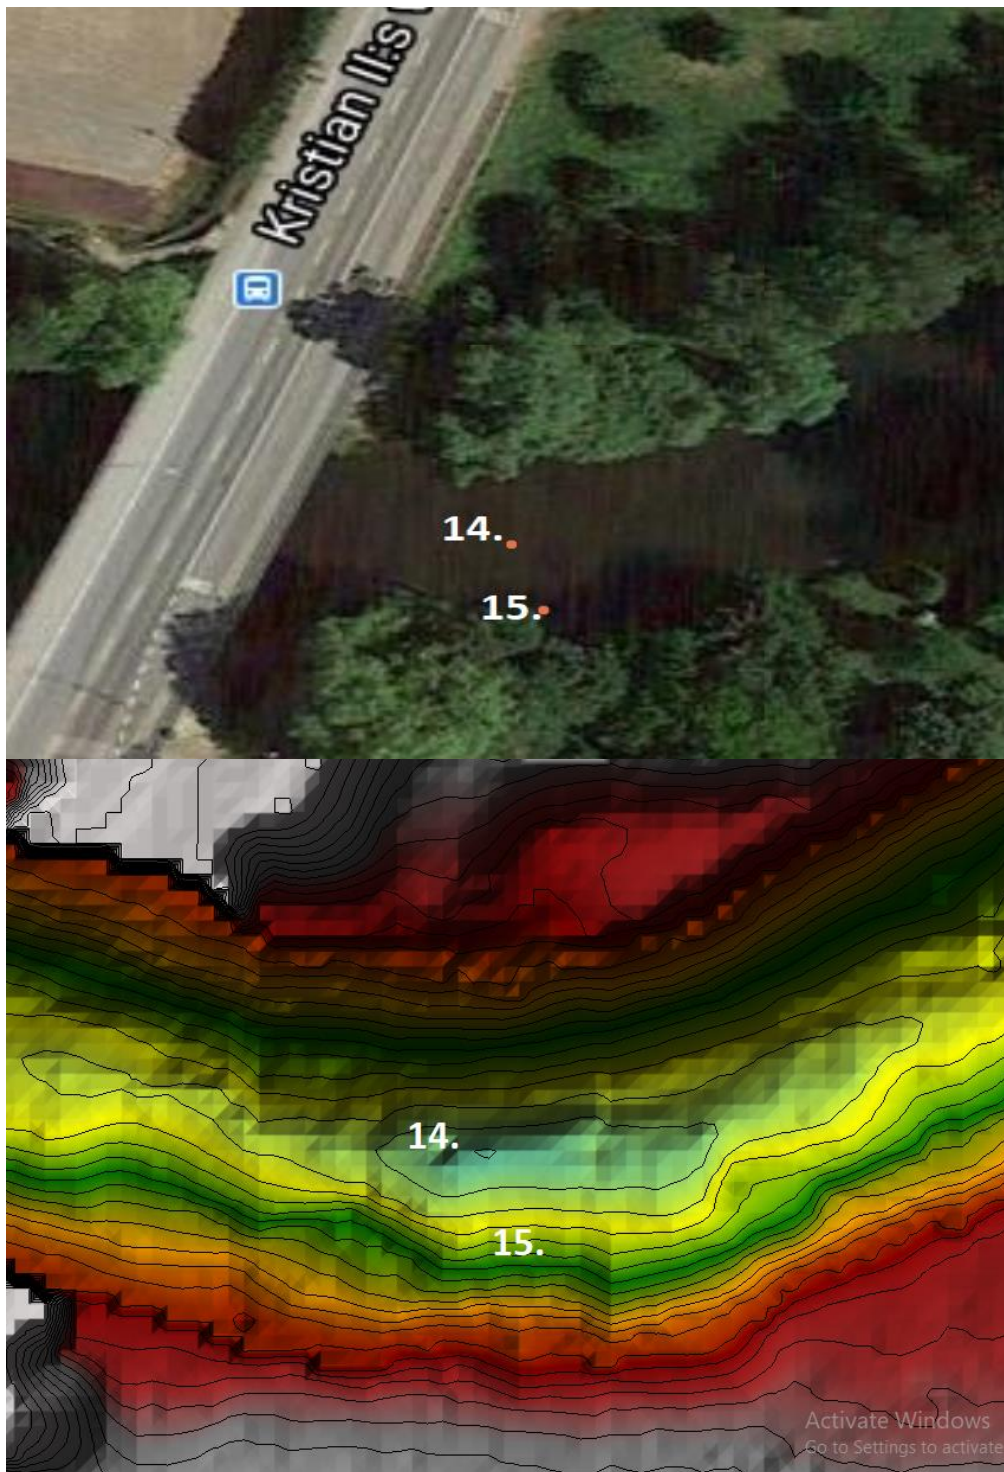
*Figure 7. Location 6 with sample points 14 and 15*

| Location | Sample points | X-Coordinate | Y-Coordinate | Remarks |
|---|---|---|---|---|
| Location 6: KP 7 + 400 m | 14 | 368098.7464 | 6235264.441 | Center of hole SH-08 (downstream) of Kristian II bron |
| | 15 | 368101.3733 | 6235257.178 | Left side of the hole SH-08, where hard bottom is expected |

The sample 6-14 was taken from the center part of a scour hole (1.5 m deeper than the normal river bottom), downstream to Kristian II bron (see figure 7). The sample textural group is characterized as sandy gravel.

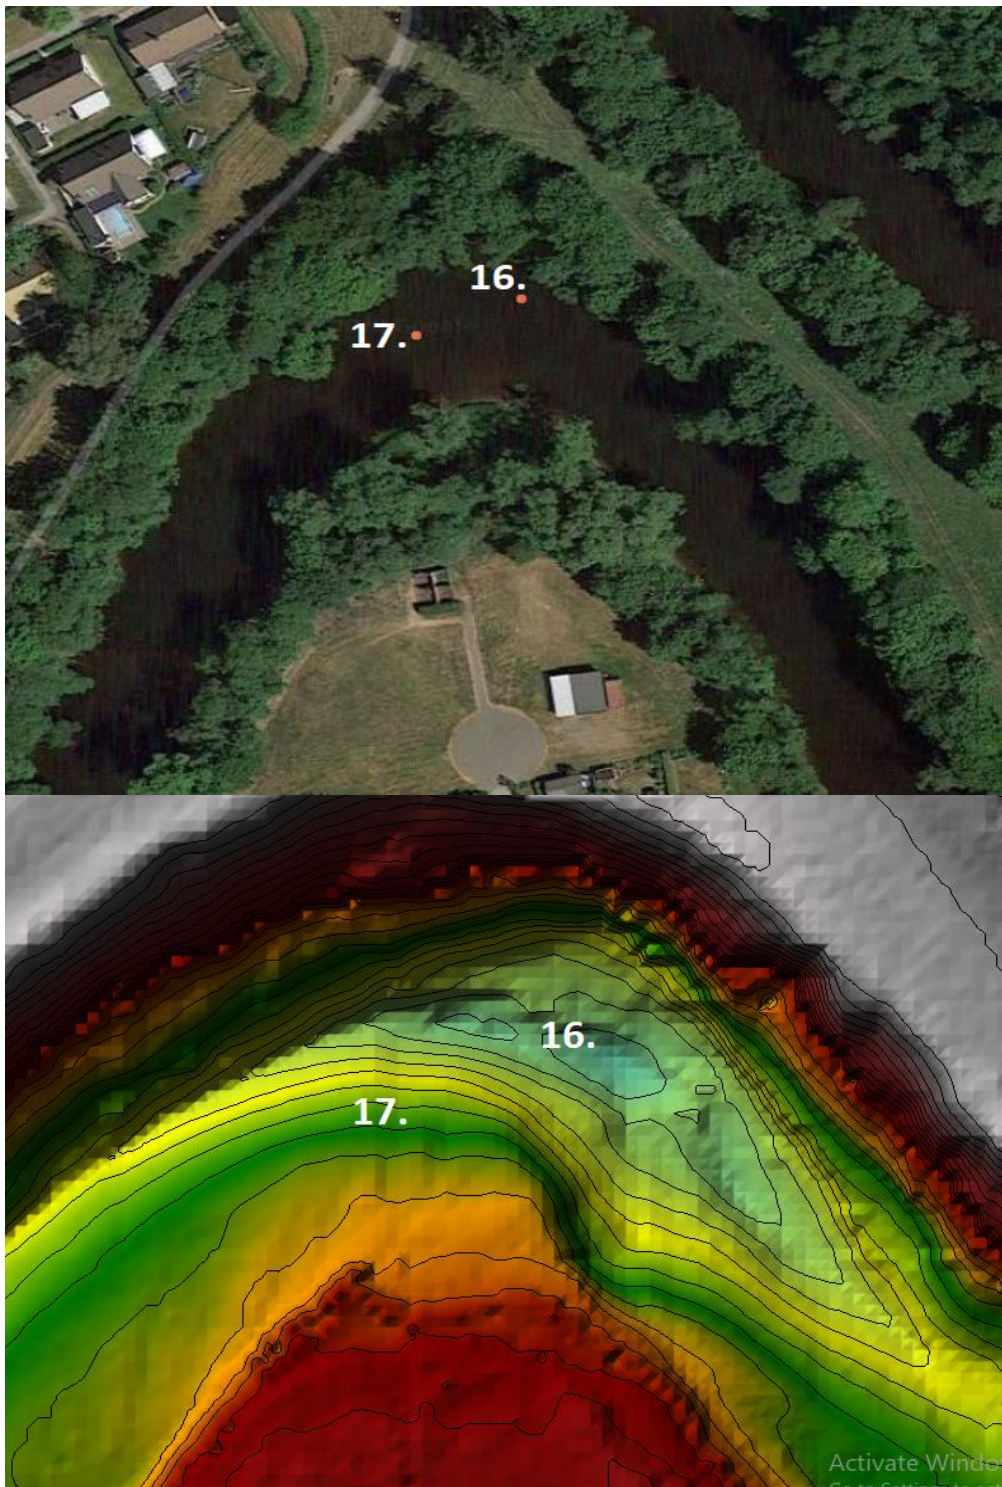
*Figure 8. Location 7 with sample points 16 and 17*

| Location 7: KP<br>9 + 650 m | 16 | 369131.6591 | 6234961.133 | Center of hole SH-12 (at strongly meandering bend) |
| | 17 | 369111.6285 | 6234953.502 | Upstream of hole SH-12, where sedimentation could occur due to pool-riffle sequences in bend |

The sample 7-17 was taken from the upstream part of a scour hole and near a sharp river bend where a riffle feature can be expected (see figure 8). The sample textural group is characterized as slightly gravelly sand.

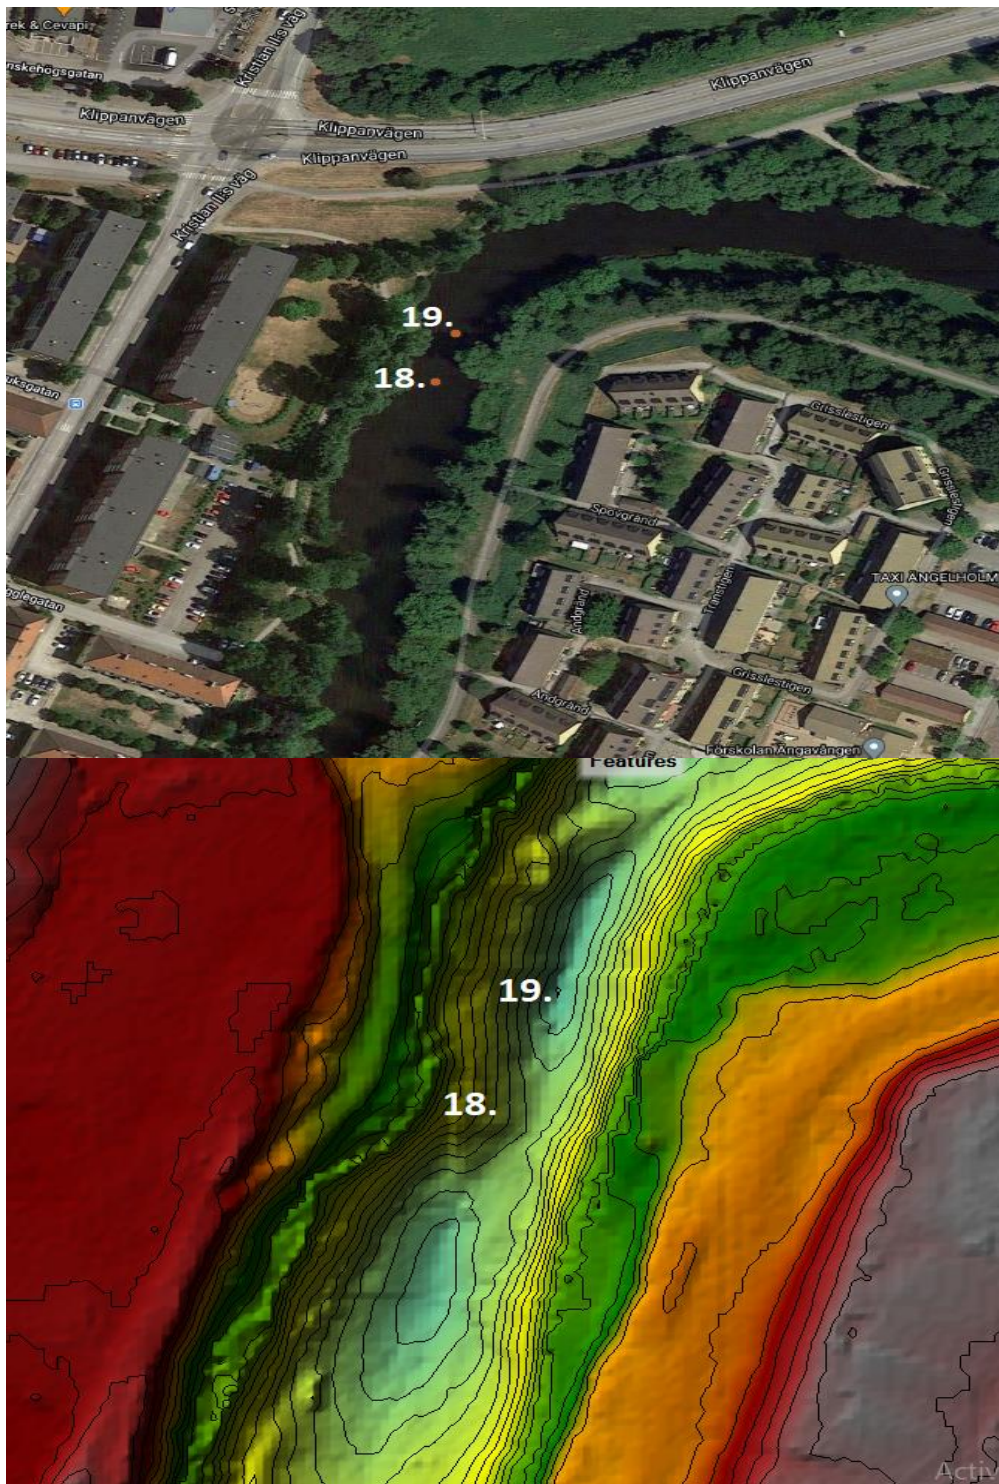
Figure 9. Location 8 with sample points 18 and 19

| Location 8 :KP<br>7+ 850 | 18 | 368332.9315 | 6235611.549 | Downstream of hole SH-10 and upstream of hole SH-09, expecting hard bottom |
| | 19 | 368339.4941 | 6235631.237 | Center of hole SH-10 (at the bend) |

The sample 8-18 was taken from the upstream part of a scour hole and near a river bend (see figure 9). Hard bottom features were expected before the sample was taken because of the formation of surrounding scour hole and adjacent river bathymetry. The sample analysis was performed visually due to lack of a sufficient sample quantity. The sample suggests that the particular bottom is hard and formed by claystone or siltstone.

The sample 8-19 was taken from center part of a scour hole (1.3 m deeper than the normal river bottom), near a river bend (see figure 9). The sample analysis was performed visually due to the sample characteristics. The sample suggests that the particular bottom is hard and layered by claystone or siltstone. Some eroding features are indicated at the top surface of the hard bottom.

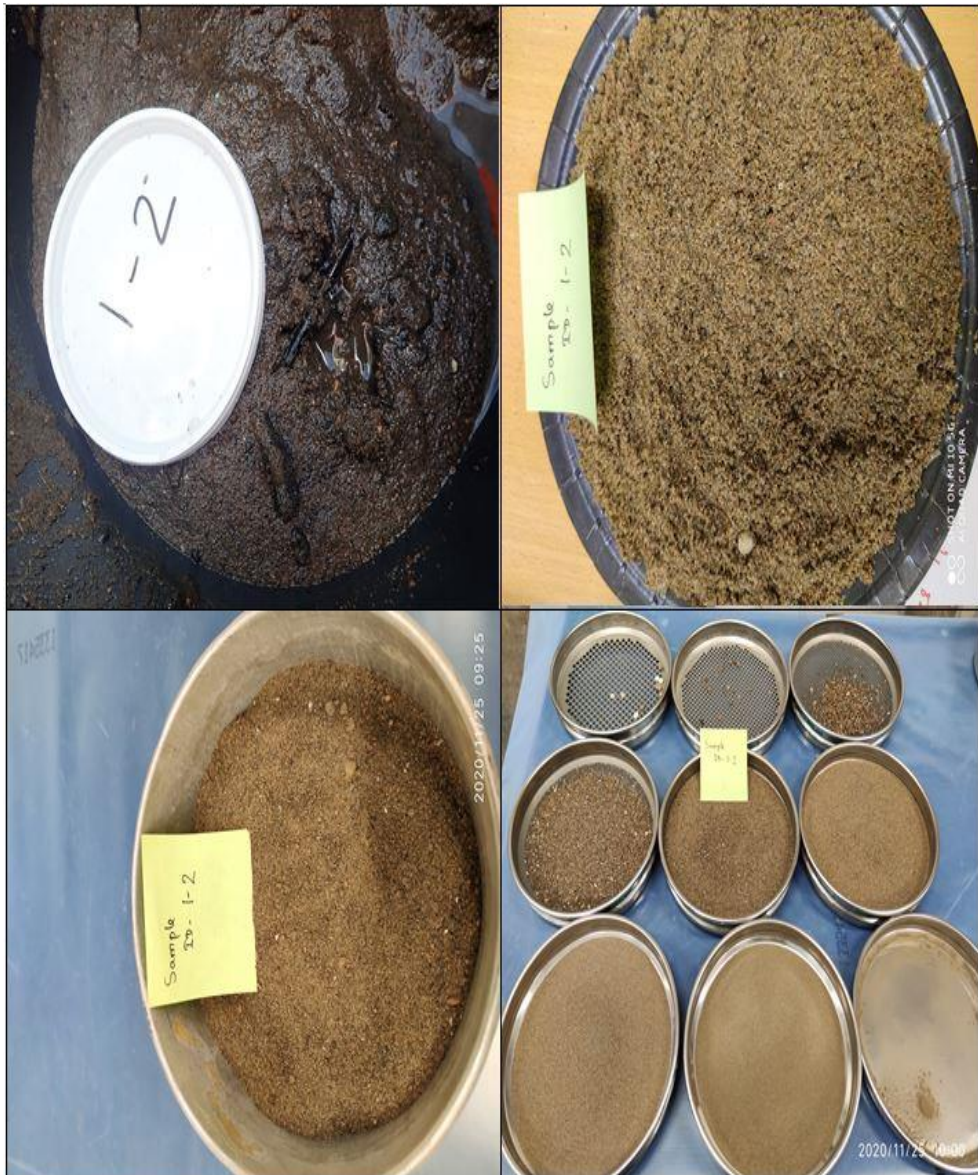
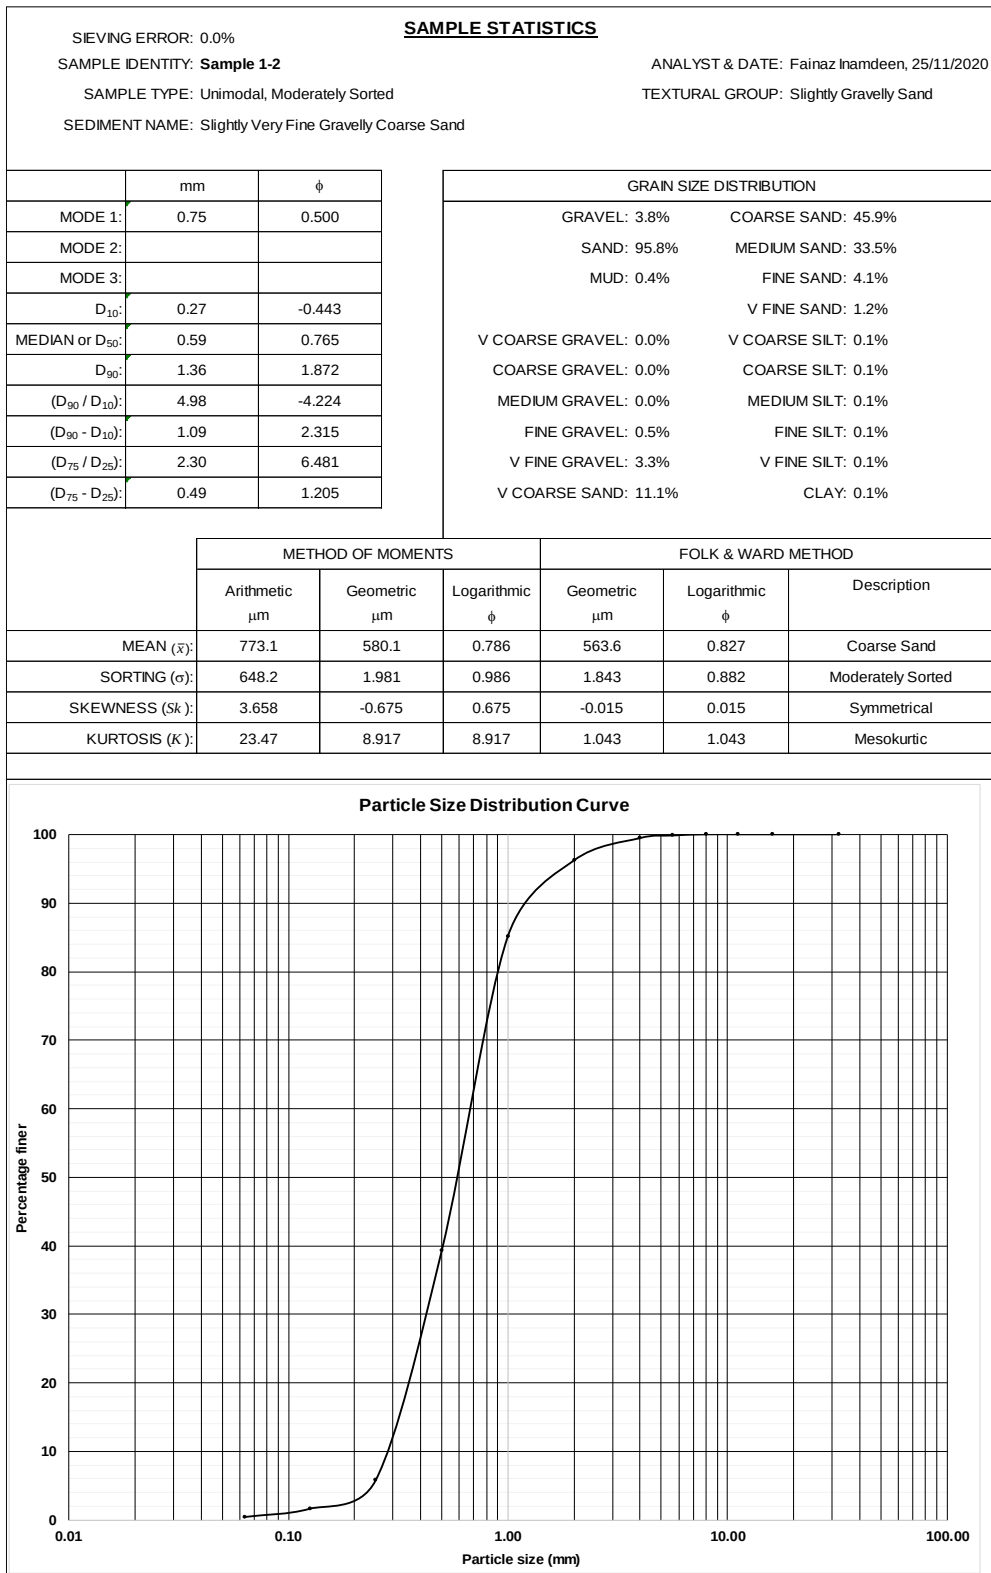
| Sample ID | $D_{50}$ (mm) | $D_{90}$ (mm) | $D_{10}$ (mm) | Textural group |
|---|---|---|---|---|
| 1-2 | 0.59 | 1.36 | 0.27 | Slightly gravelly sand |

*Figure 11. Sample 1-2 during the analysis process*

Figure 12. Sample 1-2 sieve analysis results

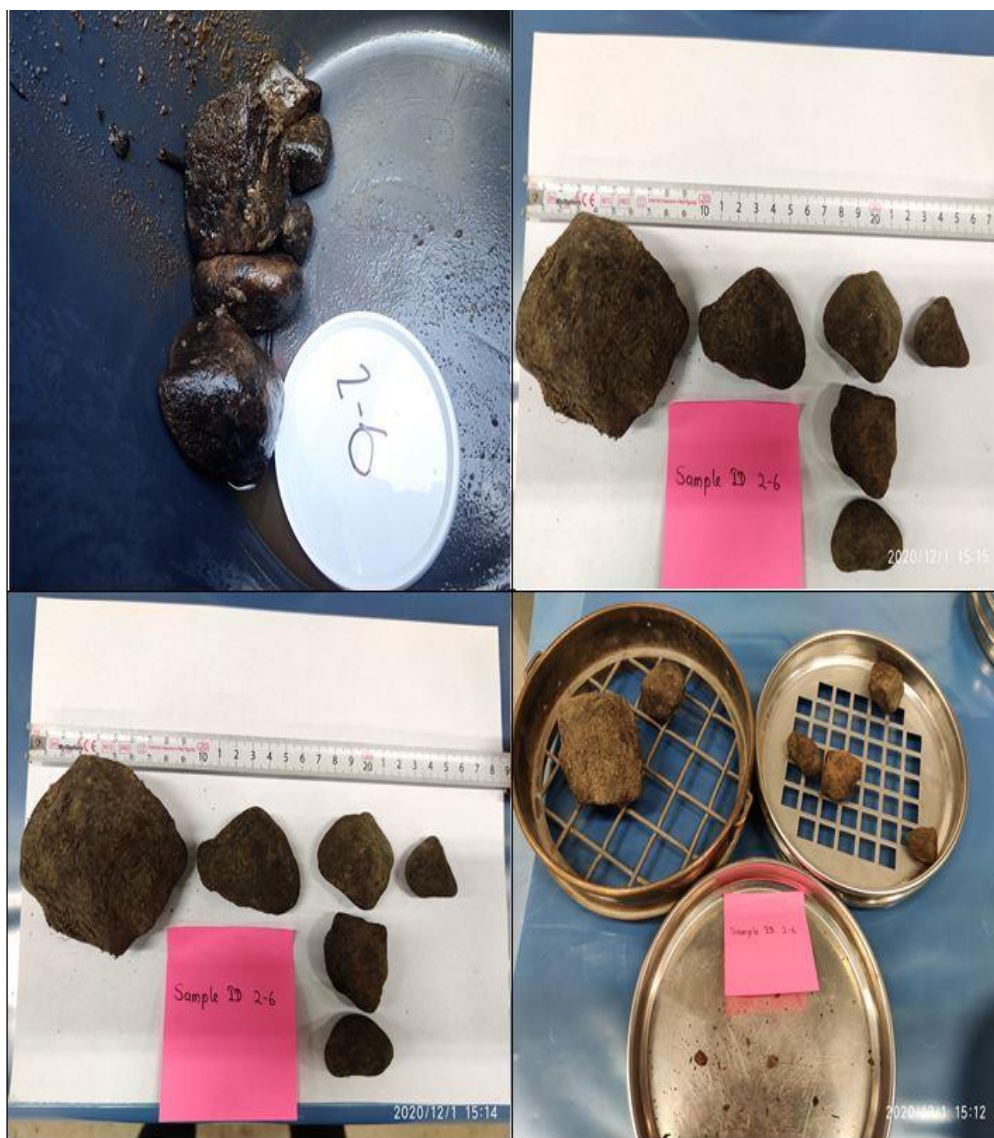
*Figure 13. Sample 2-6 during the analysis process*

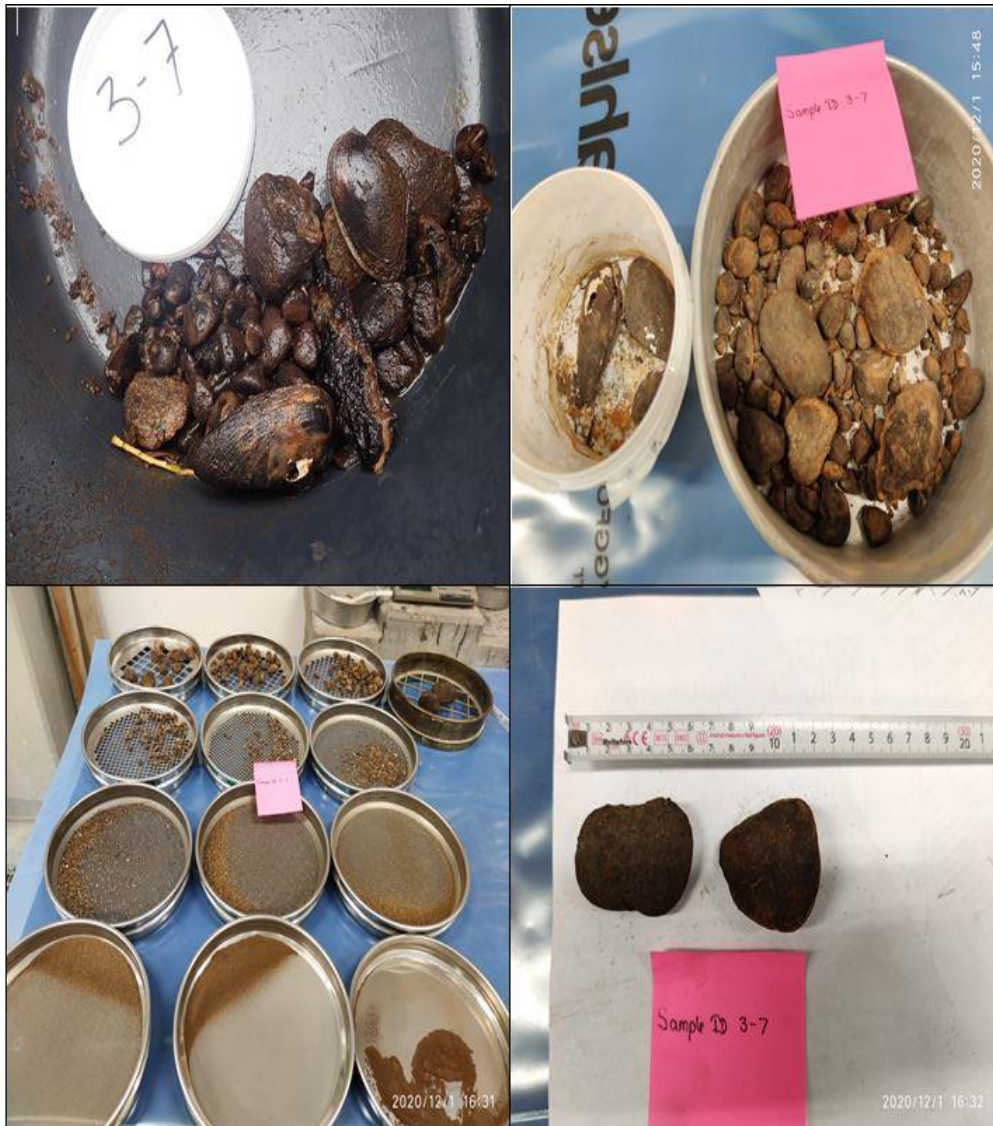
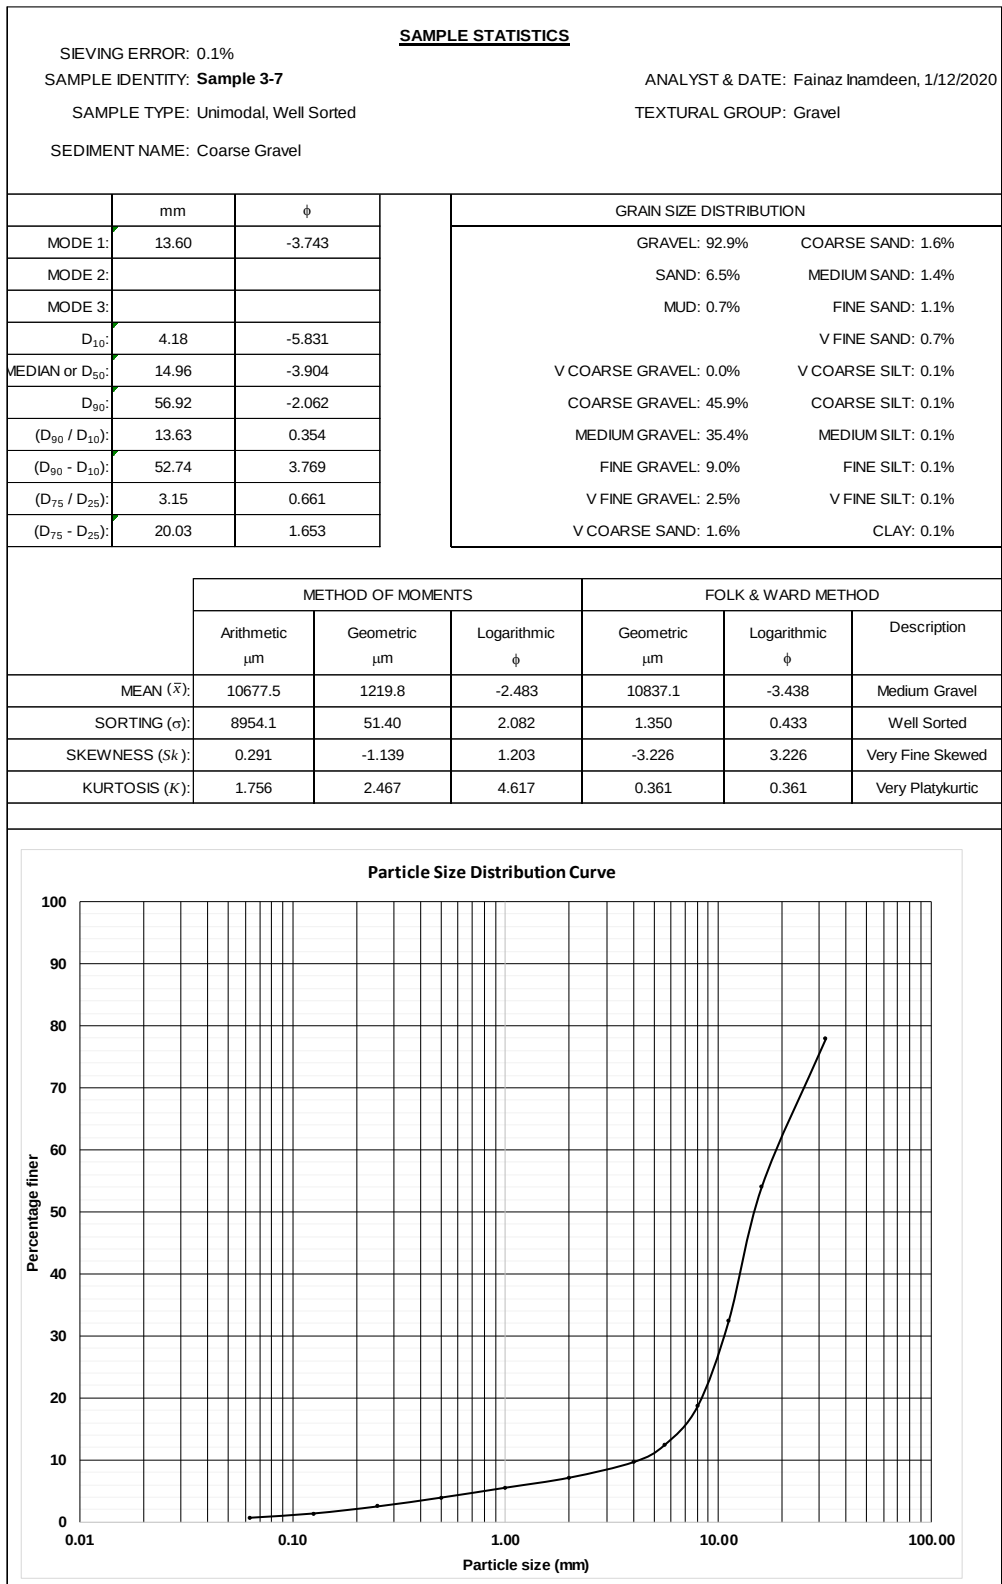
| Sample ID | $D_{50}$ (mm) | $D_{90}$ (mm) | $D_{10}$ (mm) | Textural group |
|---|---|---|---|---|
| 3-7 | 14.96 | 56.92 | 4.18 | Gravel |

Figure 14. Sample 3-7 during the analysis process

Figure 15. Sample 3-7 sieve analysis results

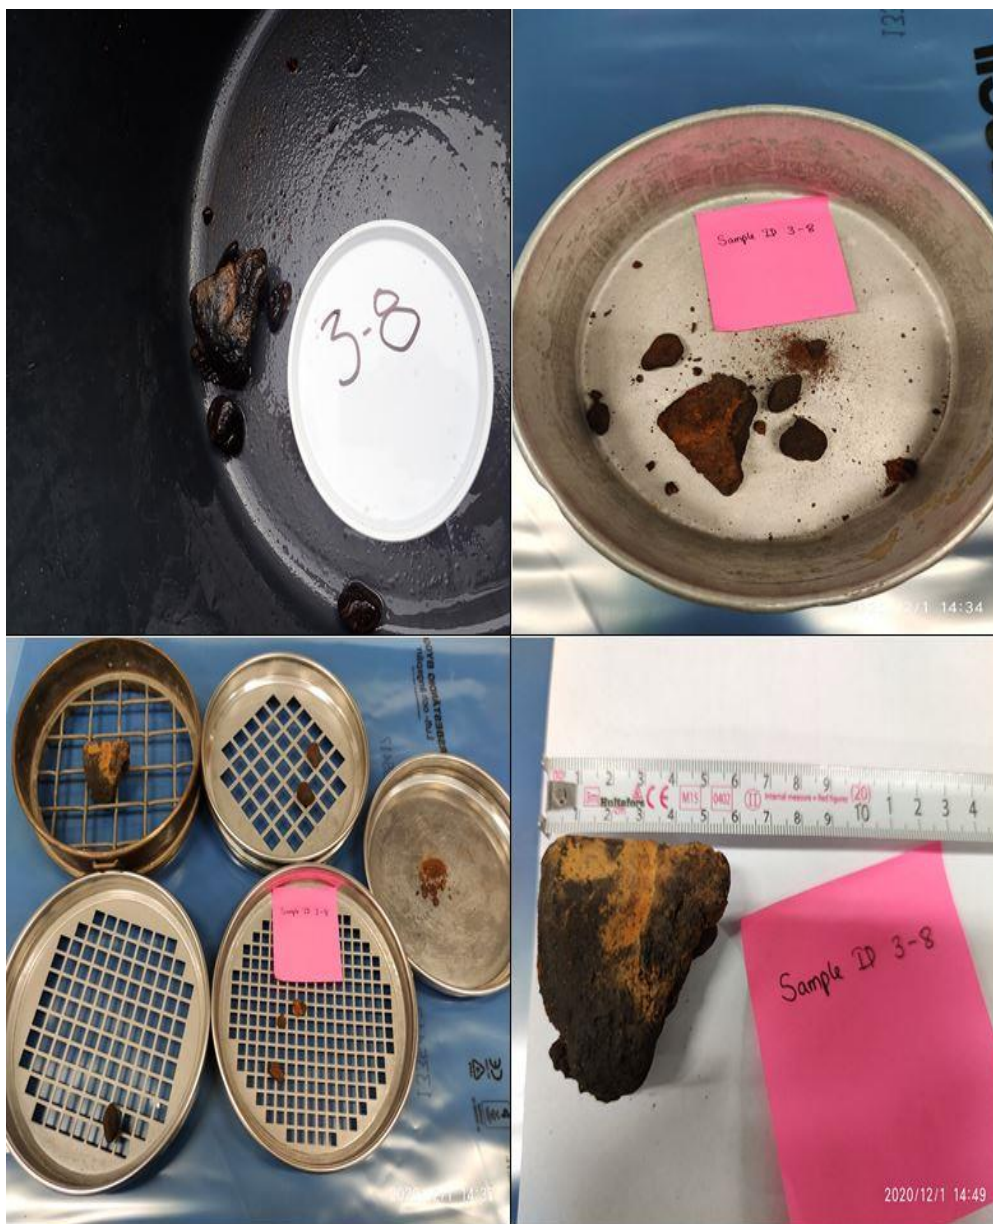
Figure 16. Sample 3-8 during the analysis process
