## Sediment Sampling and Analysis in Rönne å at Ängelholm

Inamdeen, Fainaz; Larson, Magnus

2021

Water Resources Engineering  
Report 3243  
ISSN 1101-9824

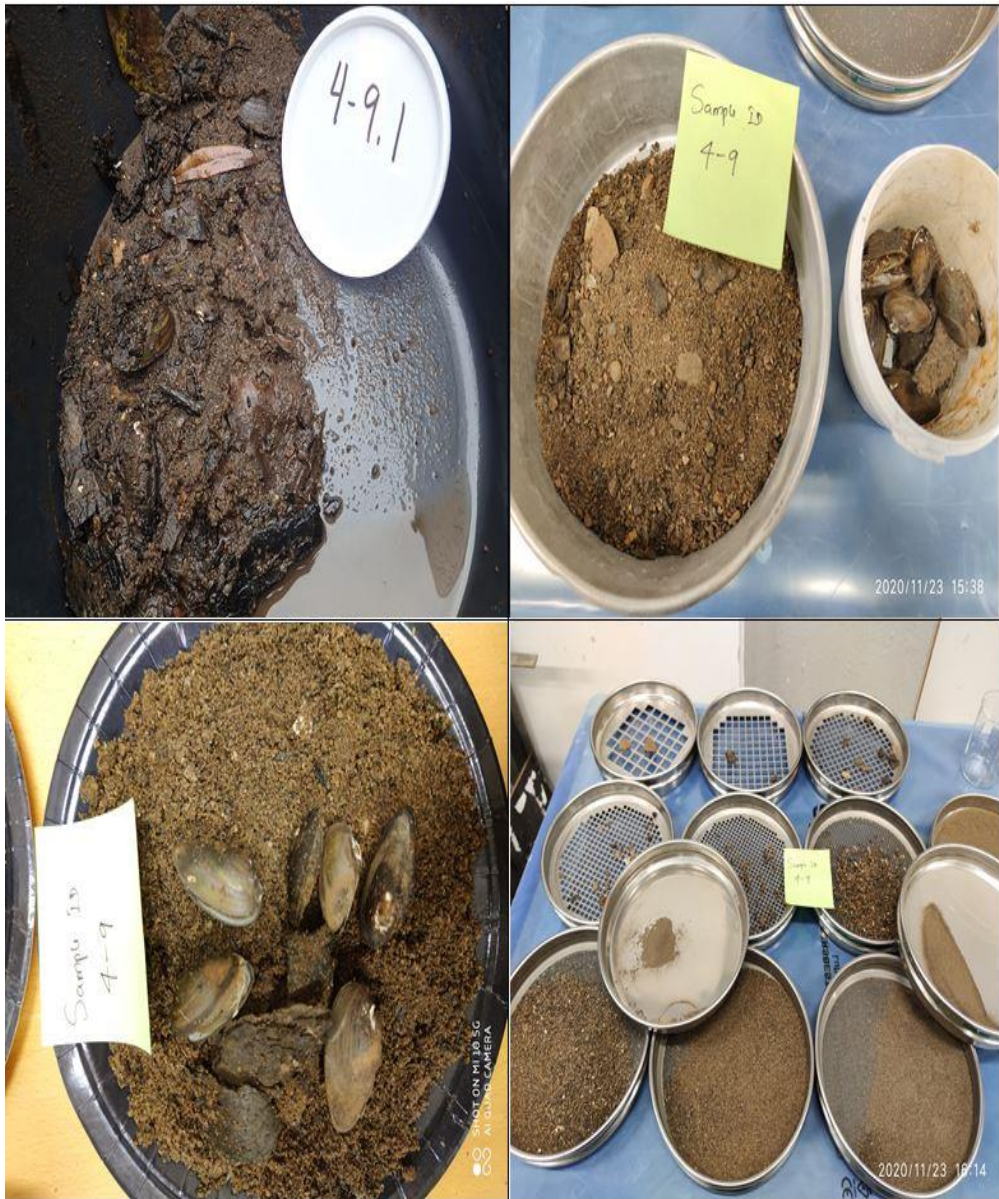
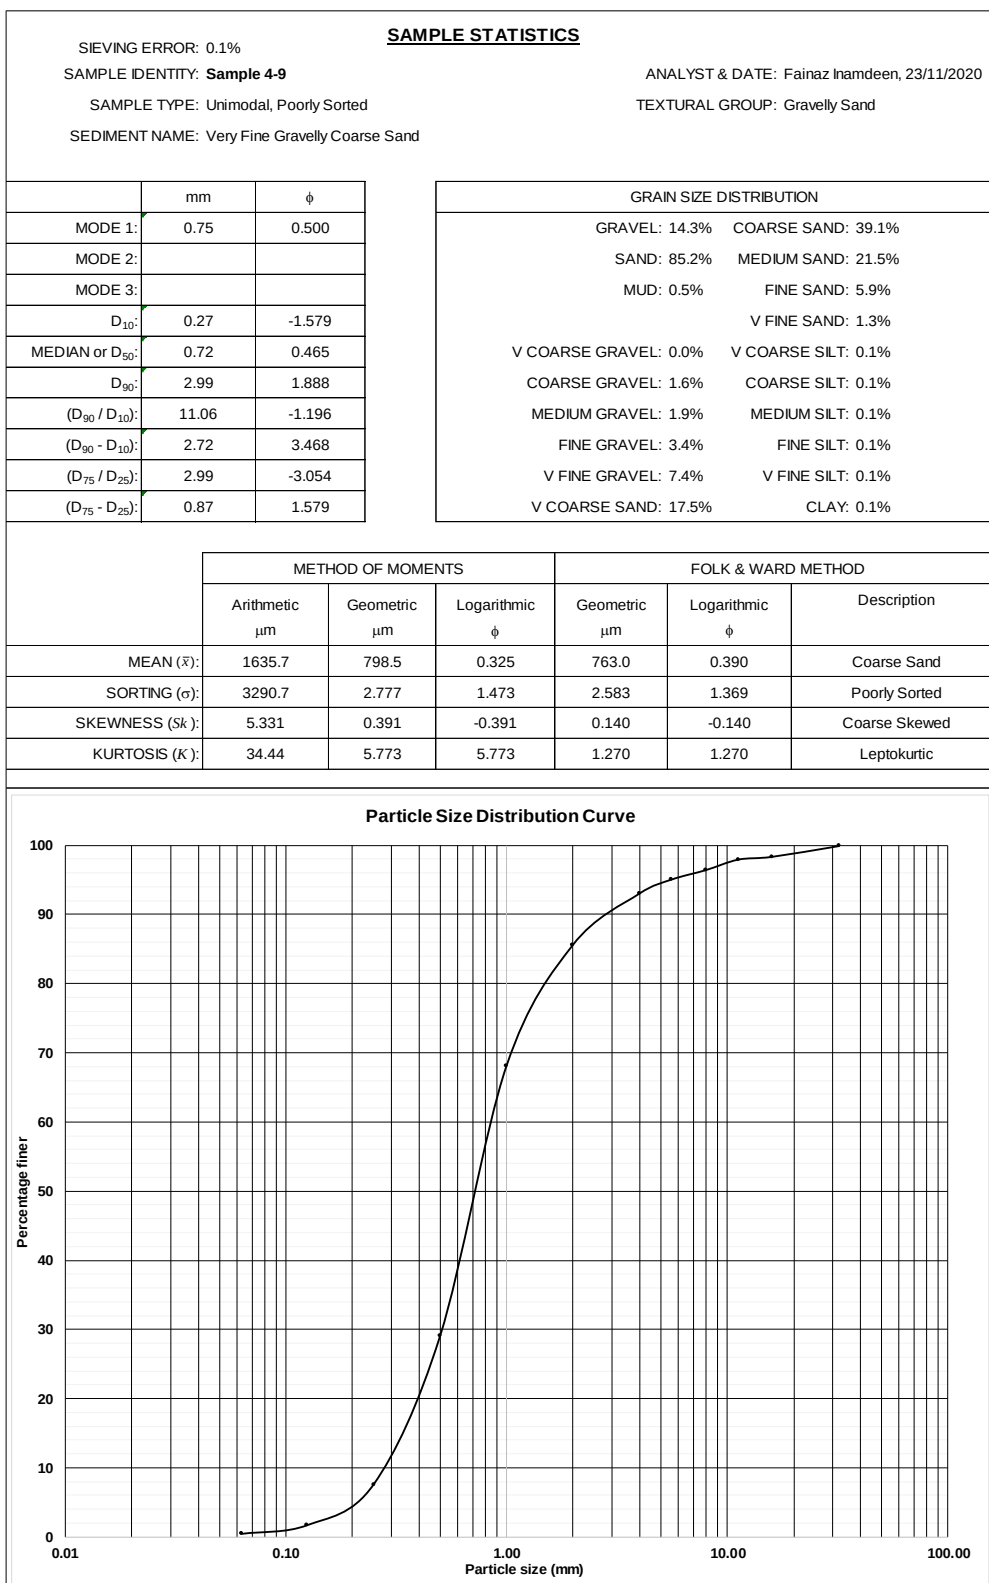
| Sample ID | $D_{50}$ (mm) | $D_{90}$ (mm) | $D_{10}$ (mm) | Textural group |
|---|---|---|---|---|
| 4-9 | 0.72 | 2.99 | 0.27 | Gravelly sand |

The sample 4-9 was taken in the downstream part of a scour hole (3.5 m deeper than the normal river bottom), near Tullportsbron (see figure 5). The sample textural group is characterized as gravelly sand. The sample was mixed with lots of mussels, as seen in pictures below.

*Figure 17. Sample 4-9 during the analysis process*

Figure 18. Sample 4-9 sieve analysis results

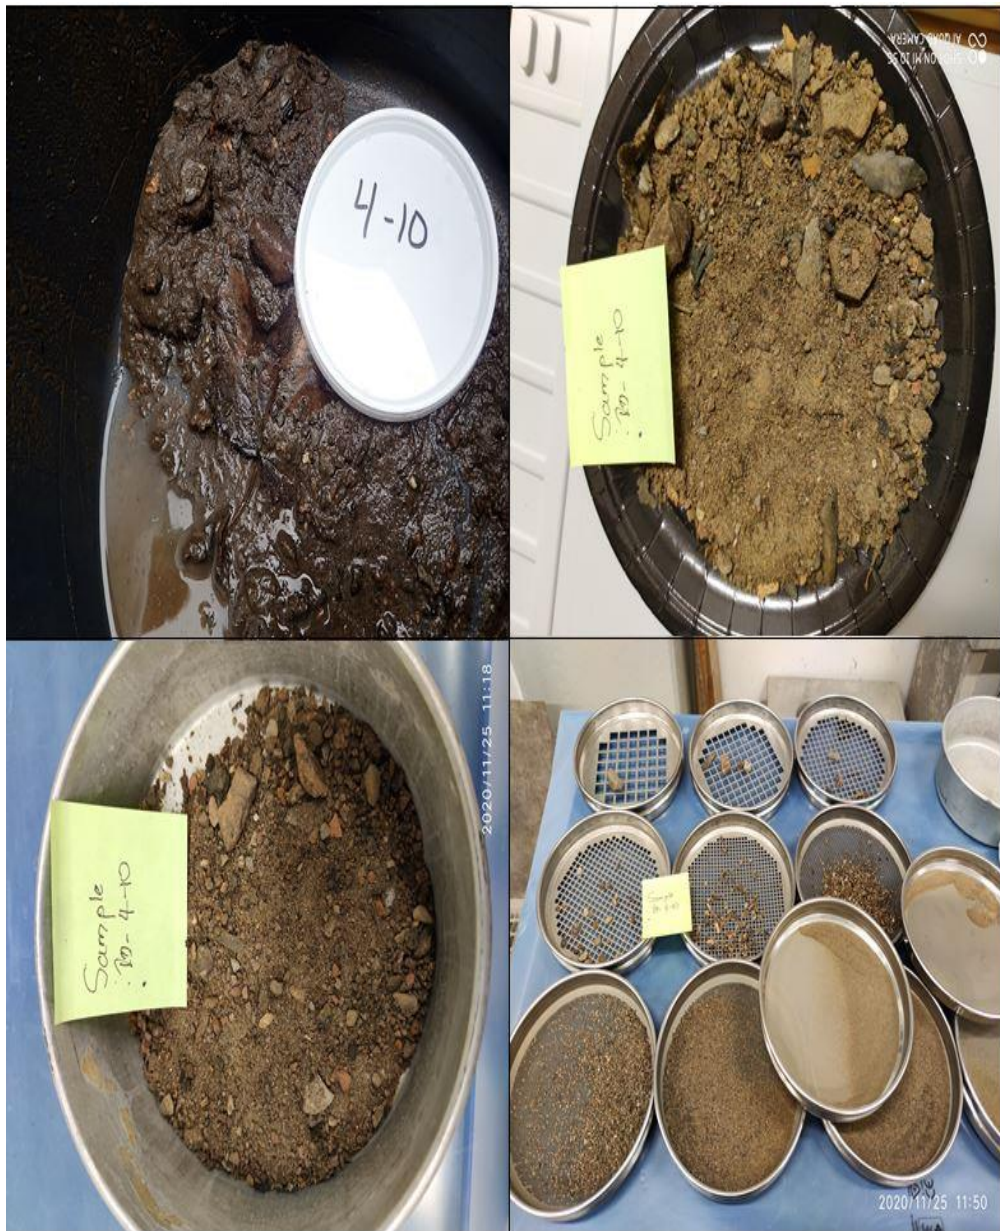
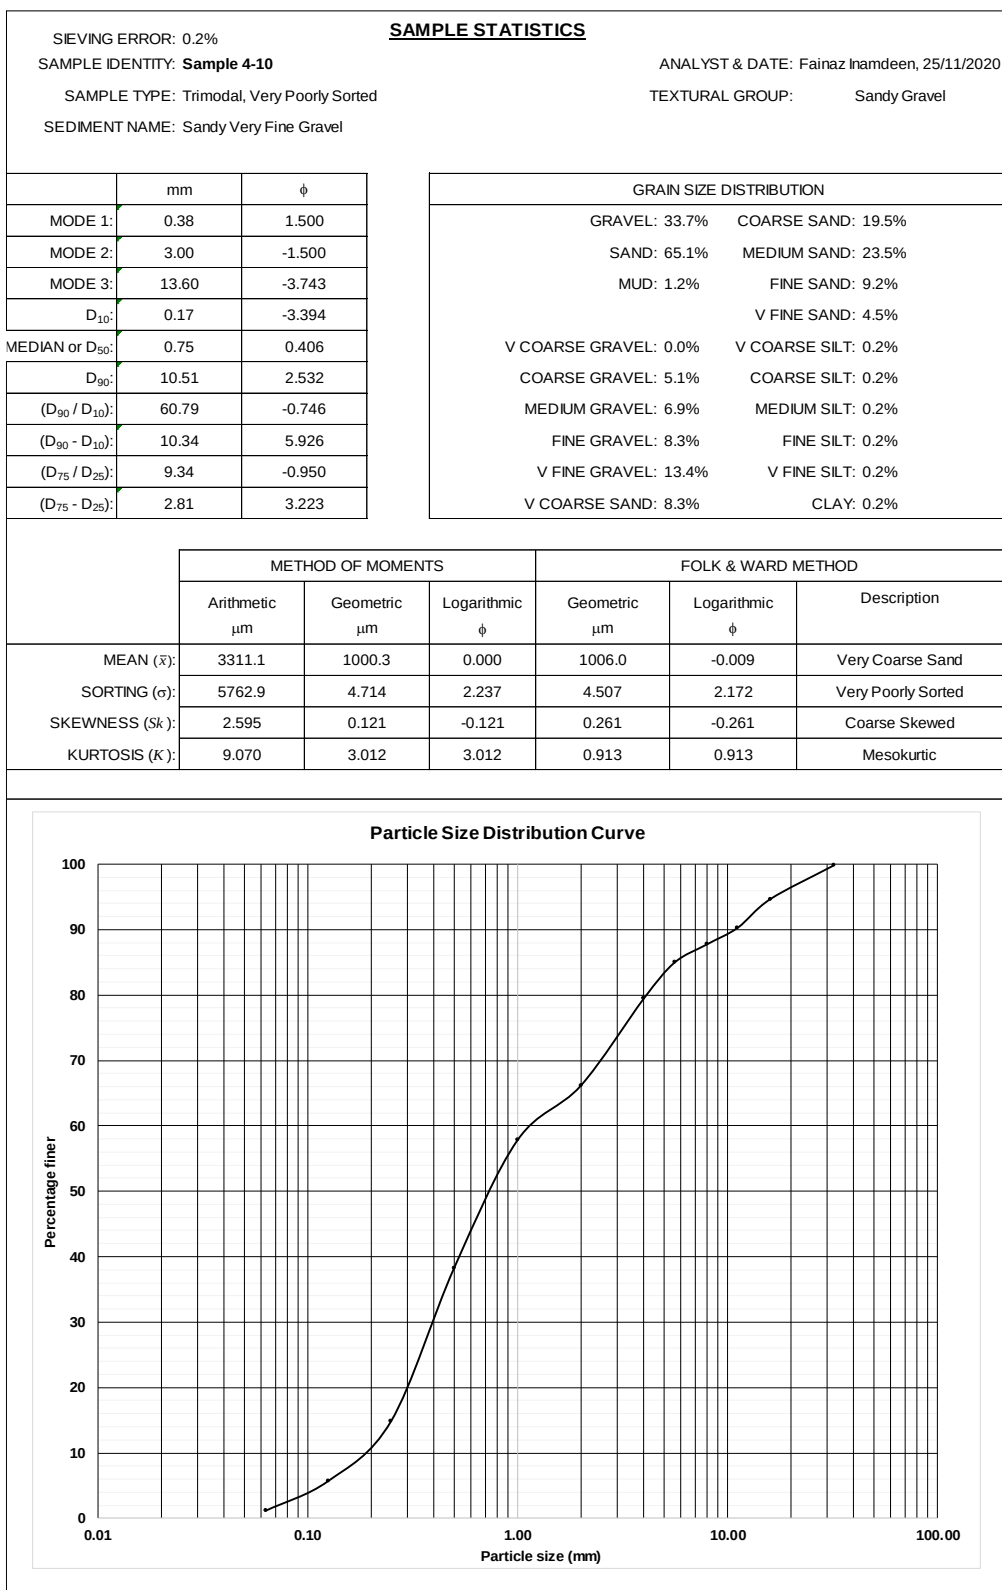
| Sample ID | $D_{50}$ (mm) | $D_{90}$ (mm) | $D_{10}$ (mm) | Textural group |
|---|---|---|---|---|
| 4-10 | 0.75 | 10.51 | 0.17 | Sandy gravel |

The sample 4-10 was taken from center part of a scour hole (3.5 m deeper than the normal river bottom), under Tullportsbron (see figure 5). The sample textural group is characterized as sandy gravel.

Figure 19. Sample 4-10 during the analysis process

Figure 20. Sample 4-10 sieve analysis results

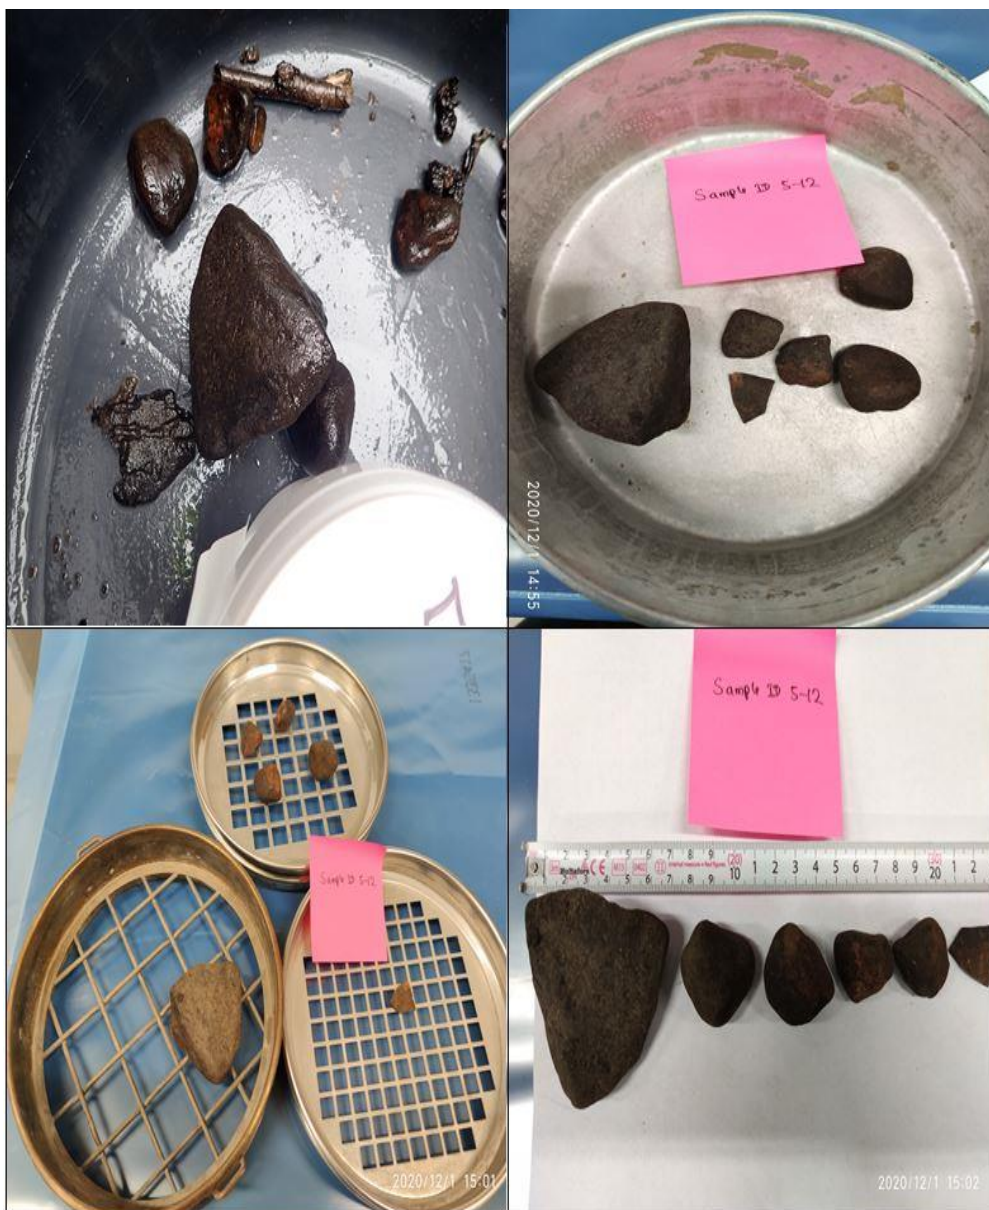
The sample 5-12 was taken from the center part of a scour hole (3.5 m deeper than the normal river bottom), near Carl XV bridge (see figure 6). The sample analysis was performed visually due to the sample characteristics and sample quantity. The sample suggests that the particular bottom is hard and contains larger rock particles.

Figure 21. Sample 5-12 during the analysis process

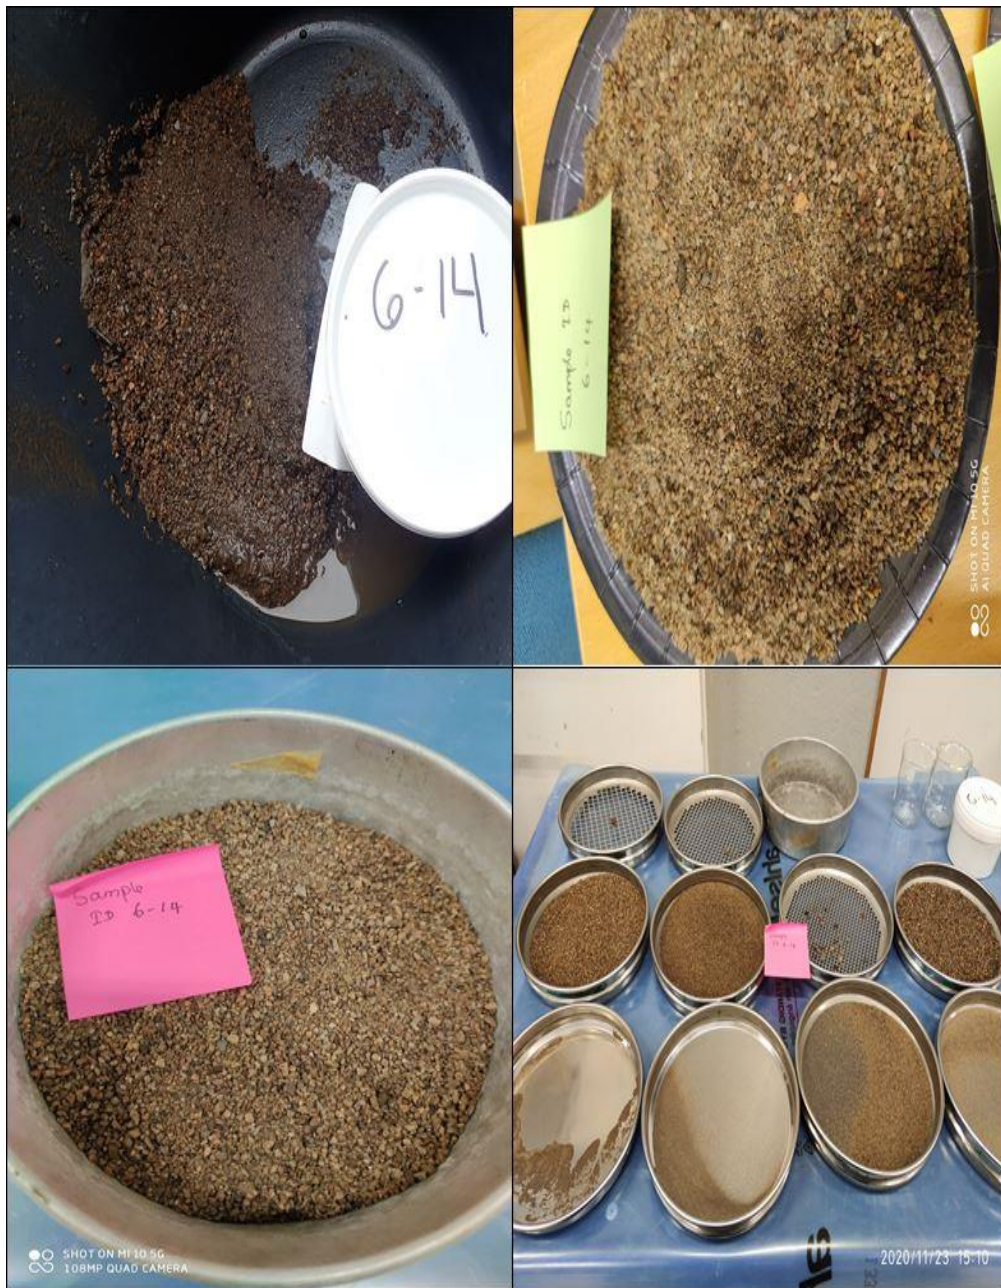
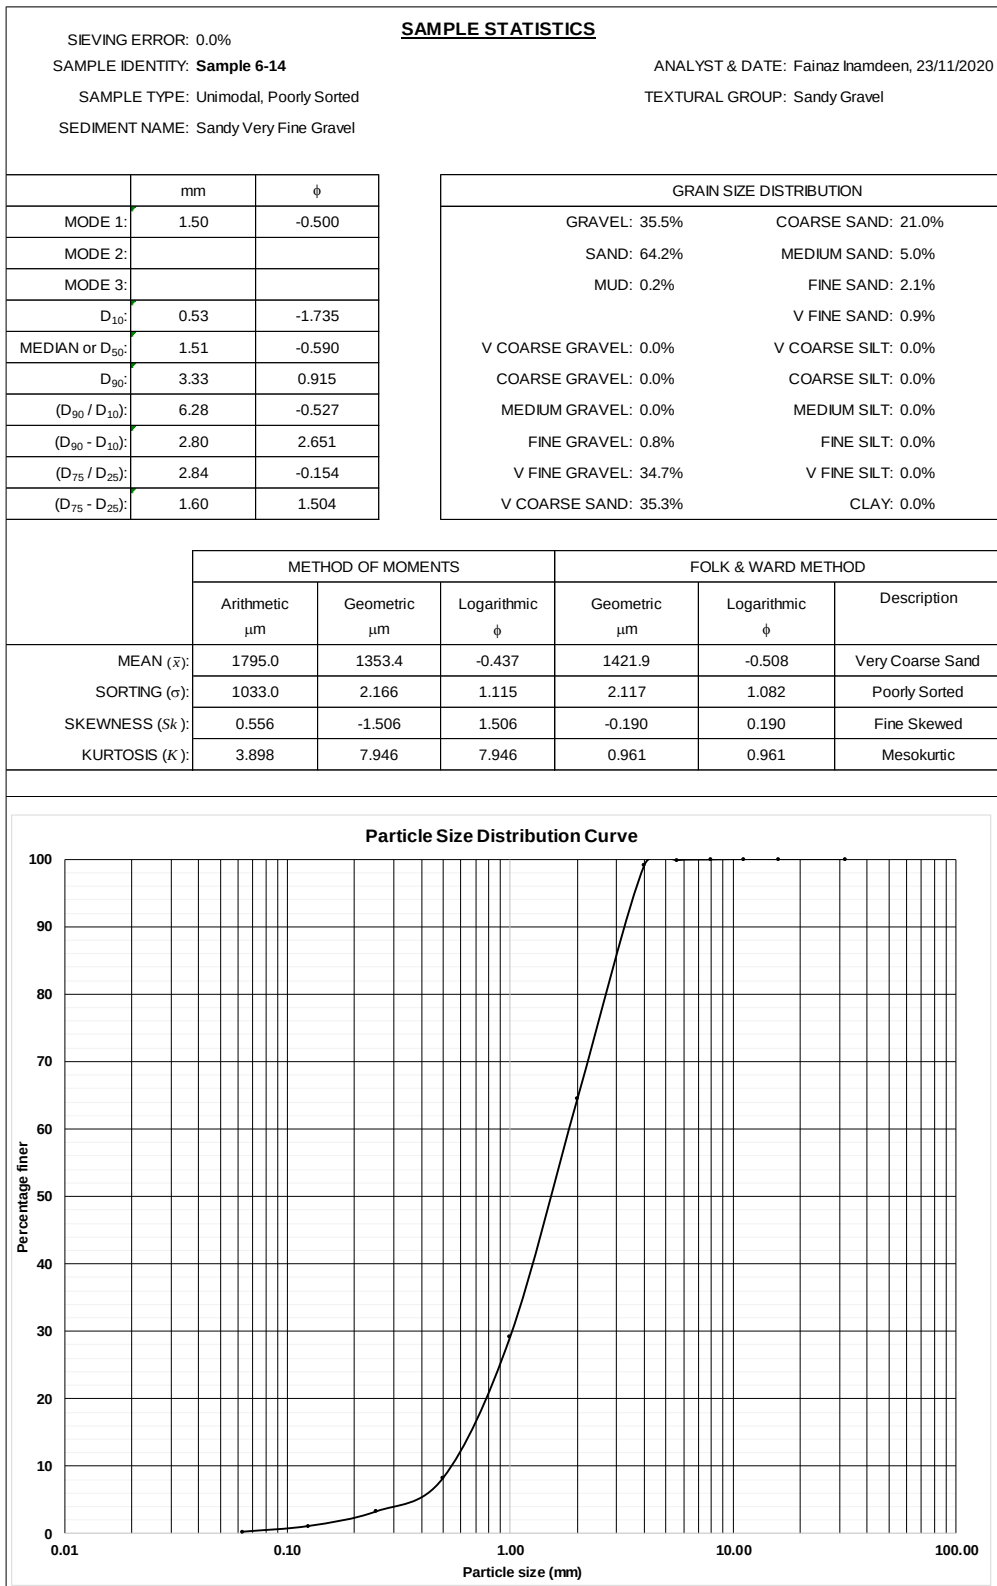
| Sample ID | $D_{50}$ (mm) | $D_{90}$ (mm) | $D_{10}$ (mm) | Textural group |
|---|---|---|---|---|
| 6-14 | 1.51 | 3.33 | 0.53 | Sandy gravel |

The sample 6-14 was taken from the center part of a scour hole (1.5 m deeper than the normal river bottom), downstream to Kristian II bron (see figure 7). The sample textural group is characterized as sandy gravel.

Figure 22. Sample 6-14 during the analysis process

Figure 23. Sample 6-14 sieve analysis results

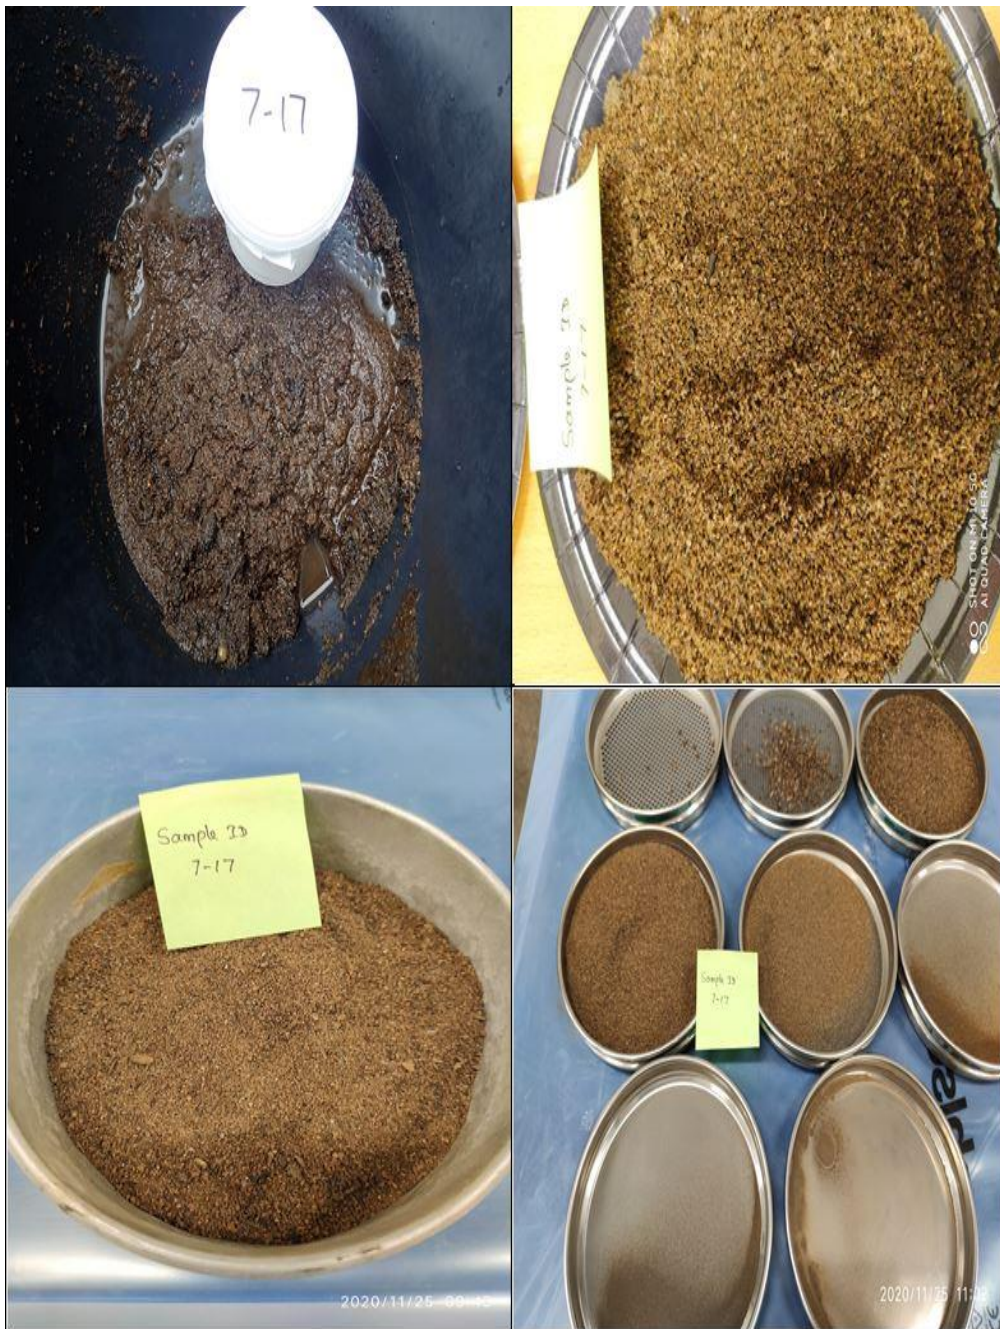
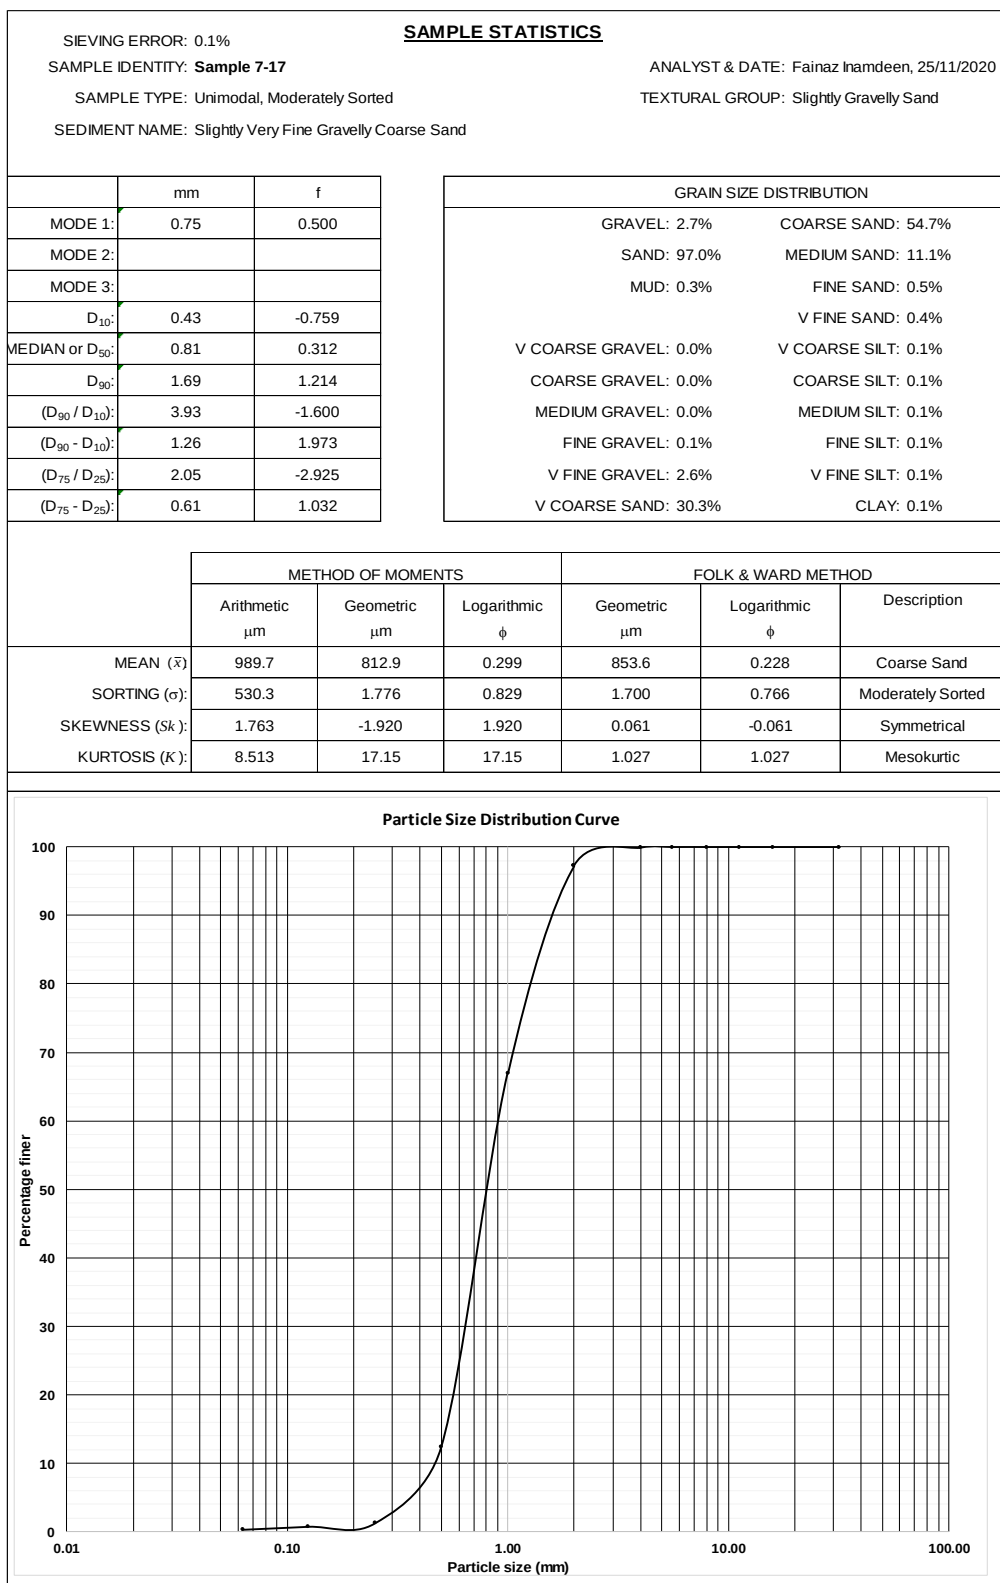
| Sample ID | $D_{50}$ (mm) | $D_{90}$ (mm) | $D_{10}$ (mm) | Textural group |
|---|---|---|---|---|
| 7-17 | 0.81 | 1.69 | 0.43 | Slightly gravelly sand |

The sample 7-17 was taken from the upstream part of a scour hole and near a sharp river bend where a riffle feature can be expected (see figure 8). The sample textural group is characterized as slightly gravelly sand.

Figure 24. Sample 7-17 during the analysis process

Figure 25. Sample 7-17 sieve analysis results

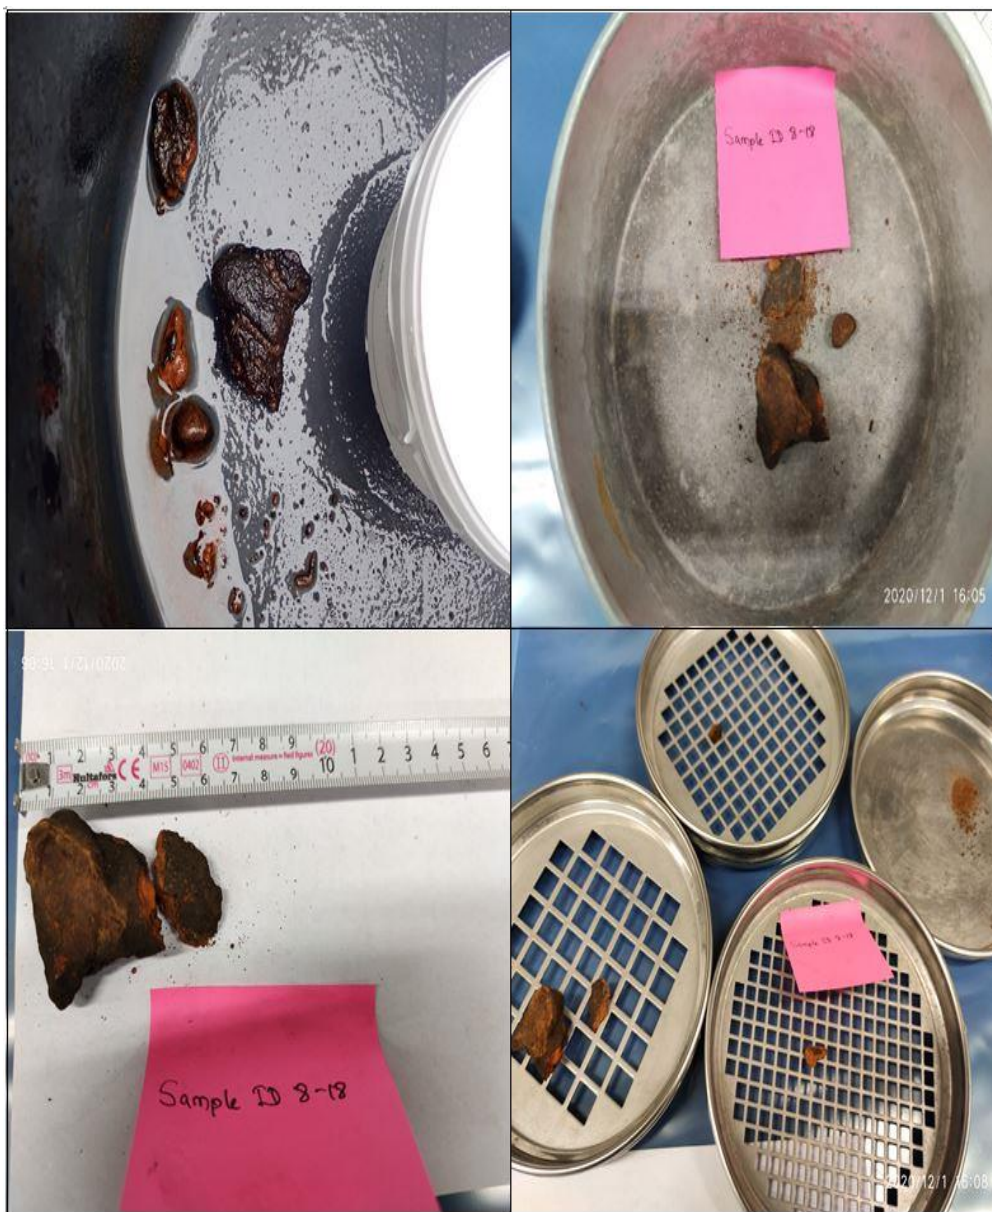
The sample 8-18 was taken from the upstream part of a scour hole and near a river bend (see figure 9). Hard bottom features were expected before the sample was taken because of the formation of surrounding scour hole and adjacent river bathymetry. The sample analysis was performed visually due to lack of a sufficient sample quantity. The sample suggests that the particular bottom is hard and formed by claystone or siltstone.

Figure 26. Sample 8-18 during the analysis process

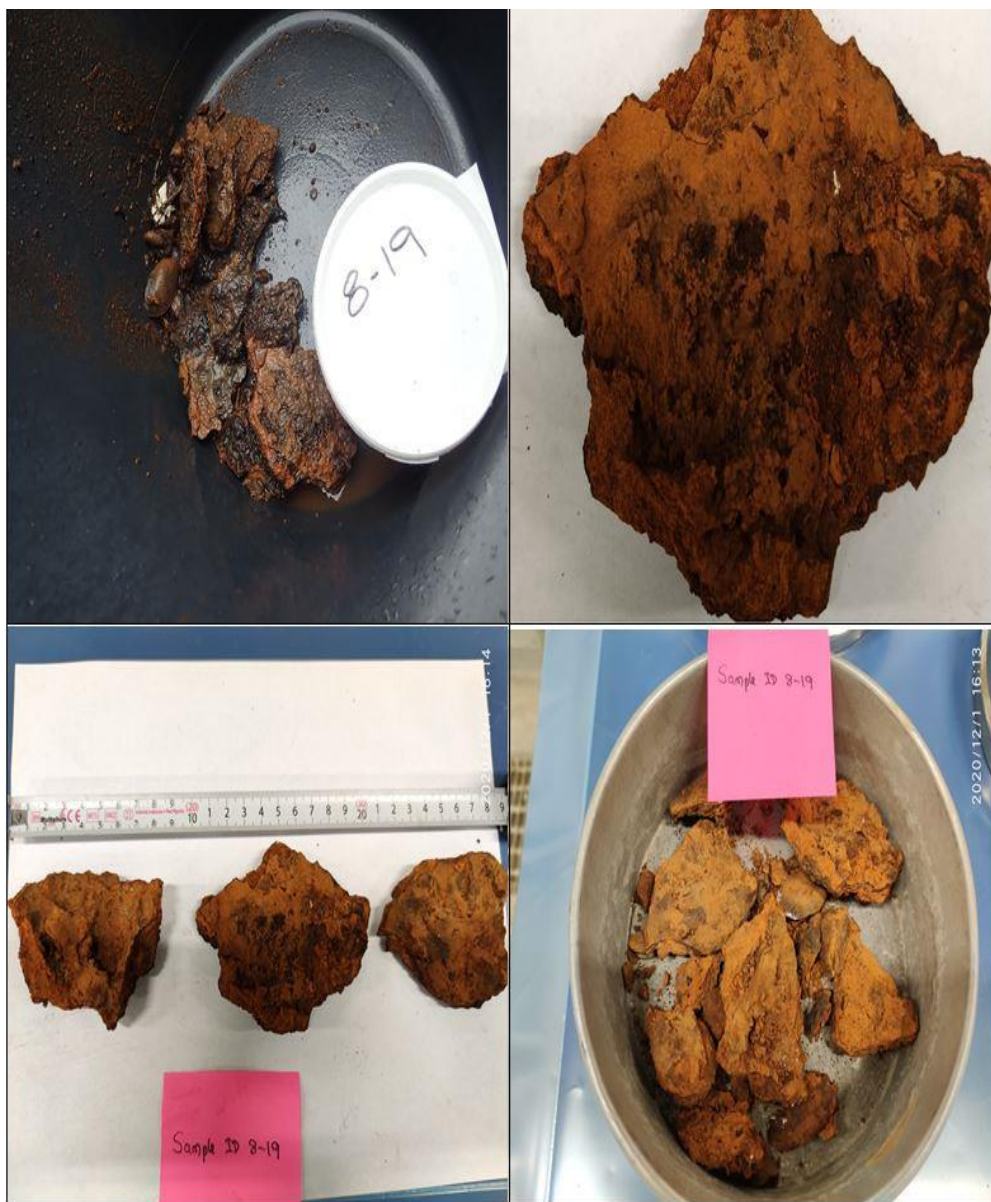
The sample 8-19 was taken from center part of a scour hole (1.3 m deeper than the normal river bottom), near a river bend (see figure 9). The sample analysis was performed visually due to the sample characteristics. The sample suggests that the particular bottom is hard and layered by claystone or siltstone. Some eroding features are indicated at the top surface of the hard bottom.

*Figure 27. Sample 8-19 during the analysis process*

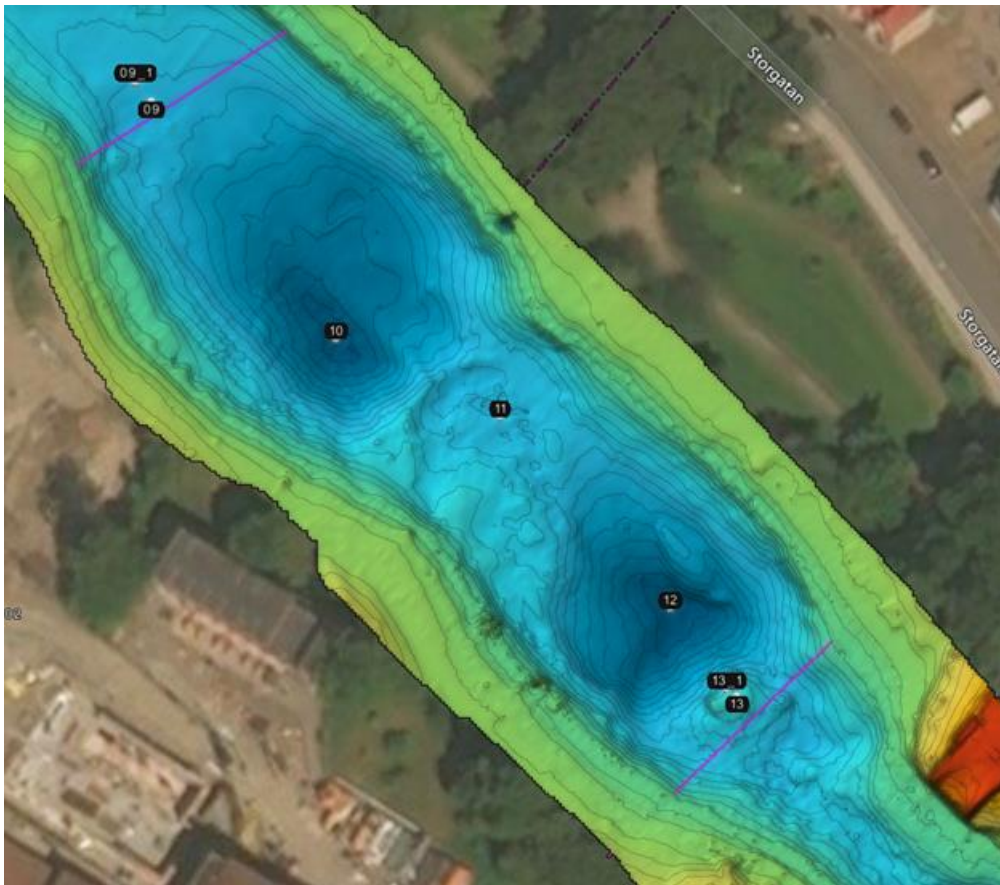
The locations of sampling points 4-9 and 5-13 (notation: location followed by sample point number; *i.e.*, 4-9 means location 4 and sample point 9) were altered by the sampling contractor MTE due to the possible presence of pipes or cable lines passing across the pre-defined locations given in the table 1.

Figure A1. The changed sample locations due to crossing infrastructure (e.g., pipe or cable crossing) over the river as marked. The sampling location was changed with regard to the LTH suggested sampling points as a measure to keep a safe distance to the infrastructure (courtesy Carl Karlsson, MarCon Teknik AB).
