Morphological development of a small-scale beach nourishment in a non-tidal area

The Proceedings of the Coastal Sediments 2023

MORPHOLOGICAL EVOLUTION OF A SMALL-SCALE BEACH NOURISHMENT IN A NON-TIDAL AREA

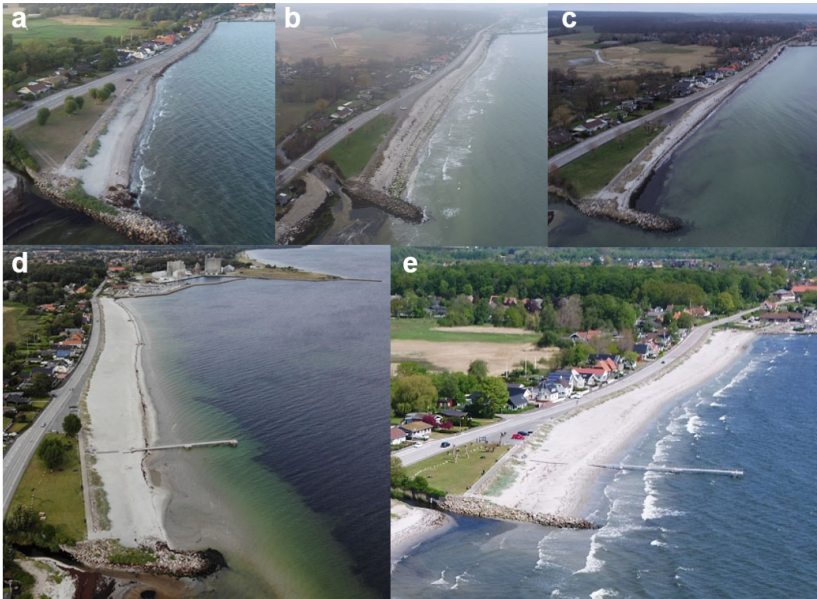
Figure 3: Drone images of Faxe Ladeplads towards the NE. The nourished area is the stretch between the harbor and the terminal groin. (a) August 2018, before the initial nourishment, (b) December 2018, just after the initial nourishment, (c) March 2020, (d) July 2021, just after the re-nourishment, (e) May 2022, including down-drift area. (Images: (a-d) Danish Coastal Authority, (e) Authors.)

The first results showed that sediment volumes from the first nourishment redistributed relatively quickly (Vinge-Karlsson & Soerensen, 2021). This nourishment had a size of 70 000 m³. The nourished material built up the cross-shore profile and distributed sediments in the direction of the dominant littoral drift (SW). It also built up a longshore bar in this area (Vinge-Karlsson & Soerensen, 2021). At the same time, the beach width rapidly reduced and a second nourishment with a size of 20 000 m³ was placed in 2021. The impact of this maintenance nourishment showed a similar re-distribution. However, the response was not as quick as the initial nourishment. The downdrift effects were still observed; the material bypassed the terminal groin (Figure 3) continuously supplying the down drift area. The cross-shore erosion rates along the stretch were not uniform along the shore. These different erosion rates were partly induced by longshore gradients in the longshore transport rates due to changes in shoreline orientation, and partly due to the result of a complex interaction with the hard structures.
