Behaviour of Multilayer External Walls with an Exterior Layer of Glazed Ceramic Tiles. Vol. 1

BEHAVIOUR OF MULTILAYER EXTERNAL WALLS WITH AN EXTERIOR LAYER OF GLAZED CERAMIC TILES

Volume 1

DIVISION OF STRUCTURAL MECHANICS AND CONCRETE CONSTRUCTION · BULLETIN 57

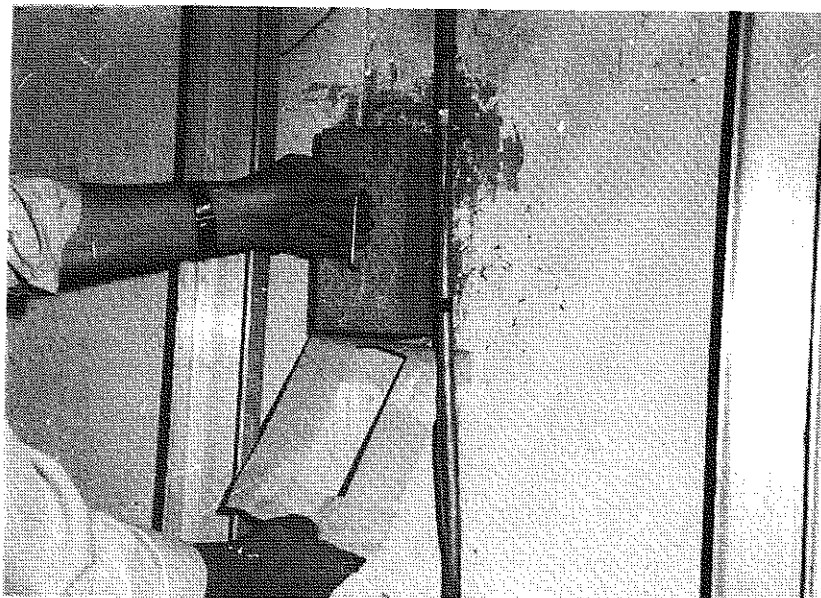
Figure 1.4.4e. The concrete test wedge in wall element no. 25, House I

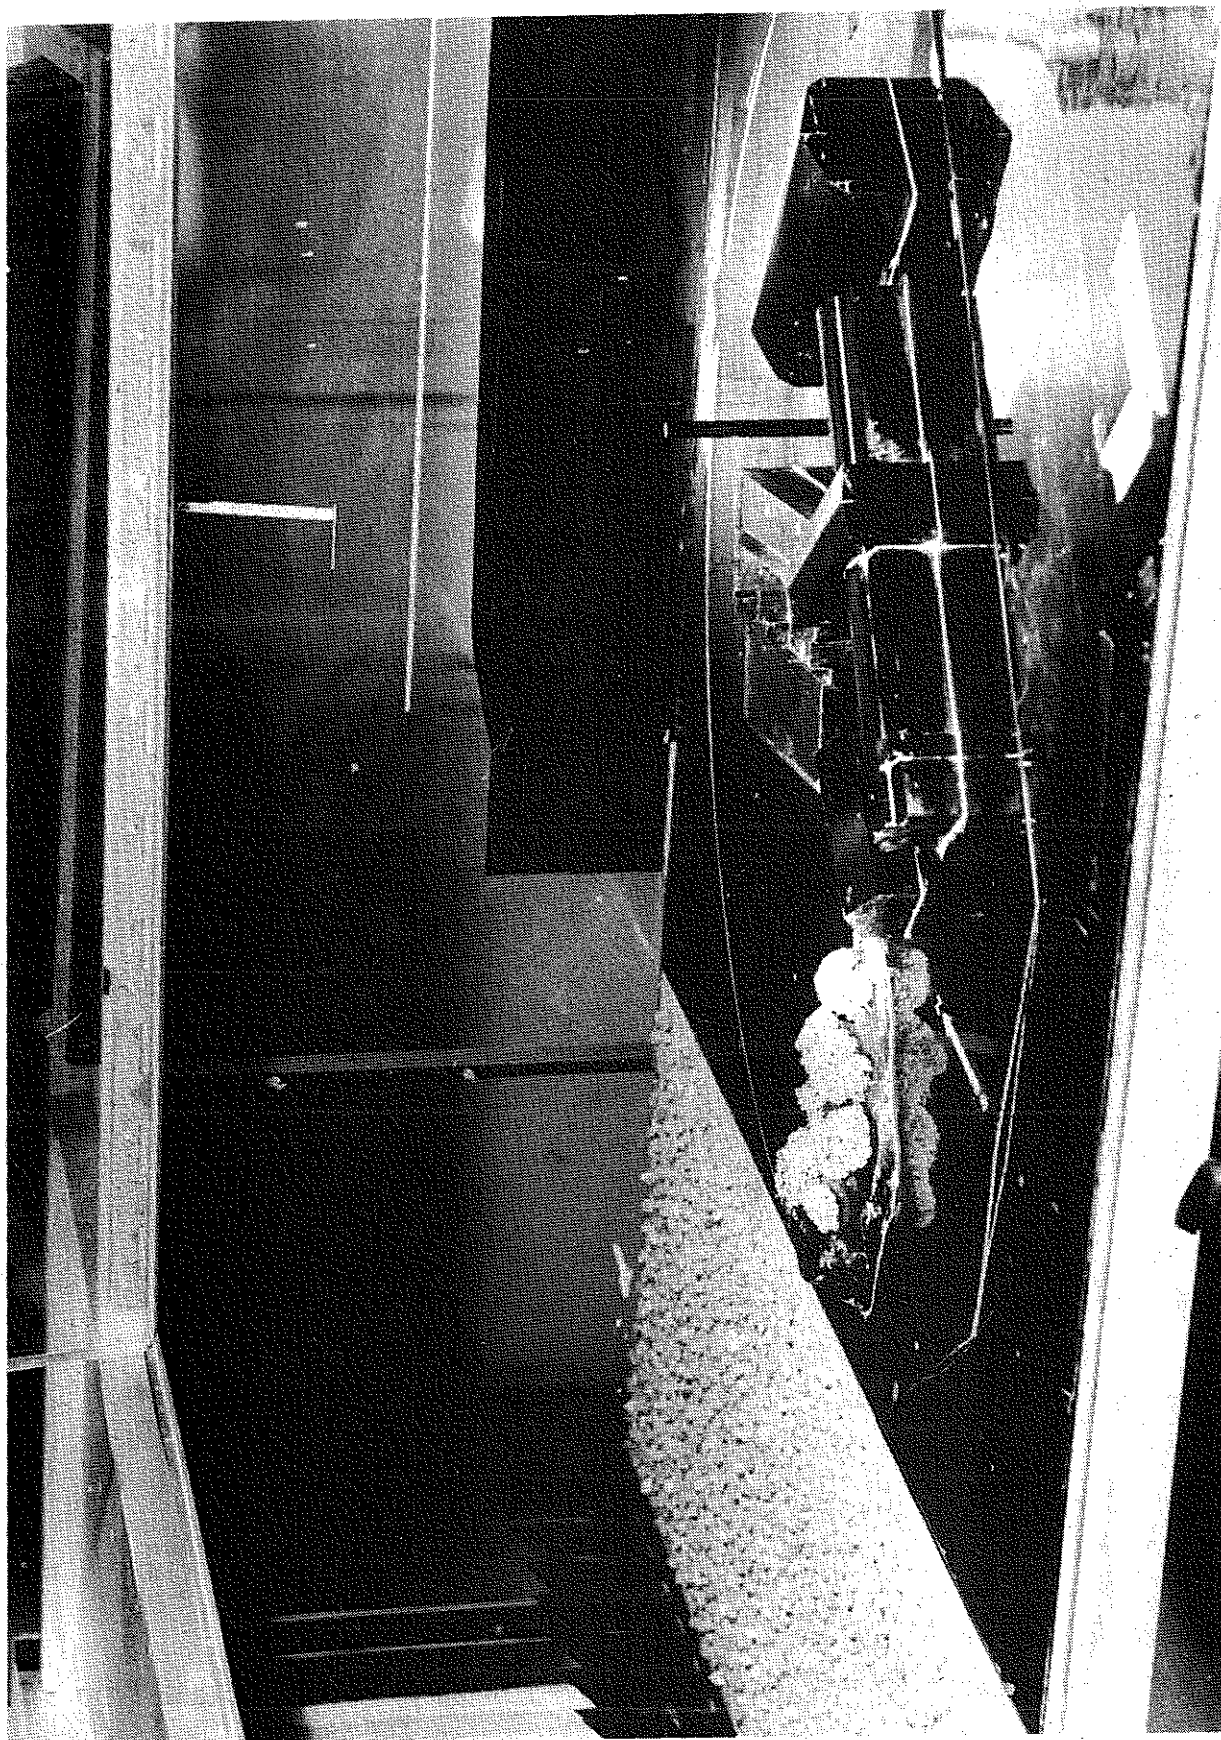
Figure A3c. The model in the test section of the FFA building aerodynamics-tunnel
