## Design of Safe Timber Structures - How Can we Learn from Structural Failures in Concrete, Steel and Timber?

Frühwald, Eva; Serrano, Erik; Toratti, Tomi; Emilsson, Arne; Thelandersson, Sven

Report TVBK-3053  
Lund 2007

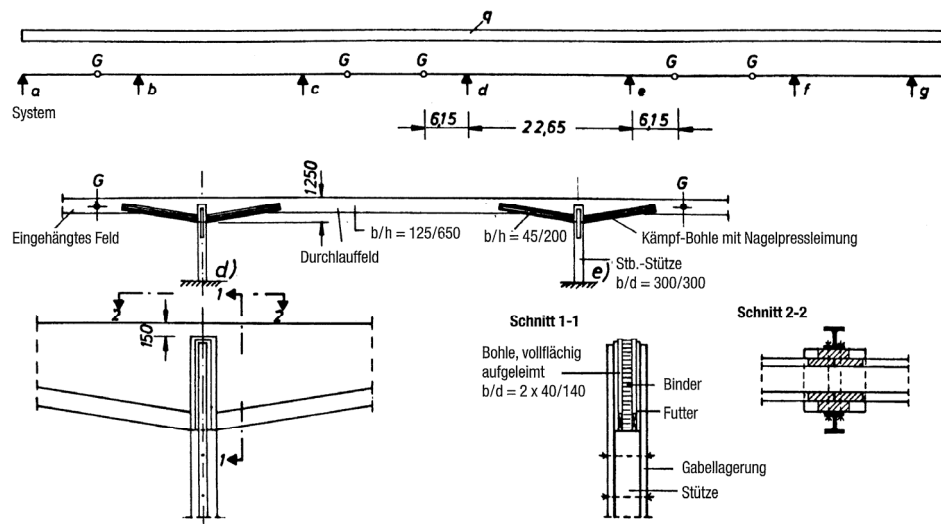
A 125 m wide industrial building is covered by continuous glulam beams with Gerber type hinges in every second span (span 22.6 m), see figure 7-1. Near the supports, the beam is tapered to increase the depth near the support. The roof is completely flat, leading to large water pools after rain. Glulam beams and purlins have been designed for uniform load comprised of dead load, extra load due to fixtures and fittings and snow load. The beams had been designed with full utilization both in the bays and at supports. As the support area is too small to transfer the support load with respect to compression perpendicular to the grain, standing boards were glued to both sides of the beam. The boards transfer the support load via their end grain to the concrete column.

Figure 7-1. Top: Continuous glulam beams of Gerber type with hinges in every second span. Middle: Strengthening with boards, glued to lower edge of beams in the tapered area, carried out after first failure. Bottom: Detail at support before first failure. Picture from Dröge G. & Dröge T.: Schäden an Holztragwerken, Schadenfreies Bauen, Band 28, Fraunhofer IRB Verlag, 2003.

The lower edges in the tapered parts were then strengthened with boards (Lamelle aus Kämpfstegplatten) that were glued to the sides of the beams, see figure 7-1. The cracks were filled with glue and the damaged beam was replaced.

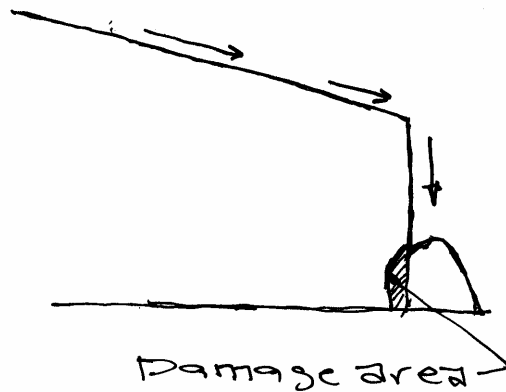
In winter of 1991, the walls were damaged by snow, as is indicated in figure 119-1.

*Figure 119-1: Snow load at time of failure.*

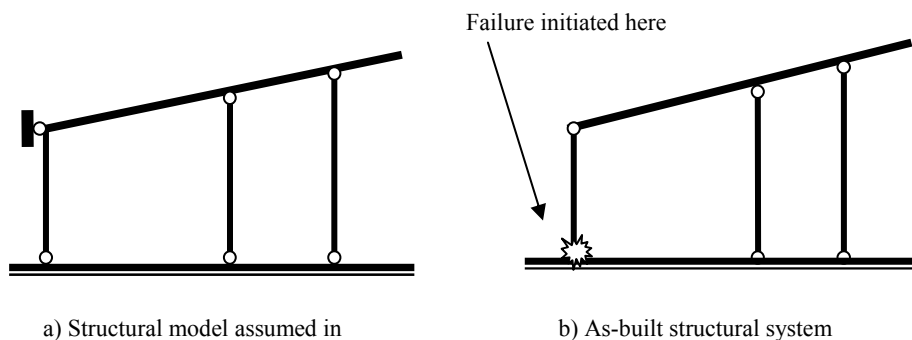
The investigation showed that the static model used in the design was very different from that realized in the as-built structure. The model assumed in design as well as the as-built structural system are shown in figure 120-1. The design was made under the assumption that the building should be braced at the roof level, figure 120-1a, but no bracing was provided at this level. The columns were designed as pin-jointed in both ends. Just after erection the system became unstable and moment failure occurred at the lower support of the short column.

The failure was caused by use of wrong structural model in the design, which was made with a computer program which automatically generated the structural model. The designer did not realise that the generated model was valid only under the assumption that wind bracing should be arranged at the roof level.

*Figure 120-1: Assumed and real structural systems*

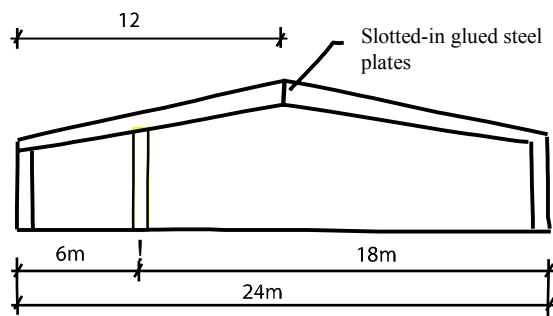
Figure 122-1: Glulam structure.

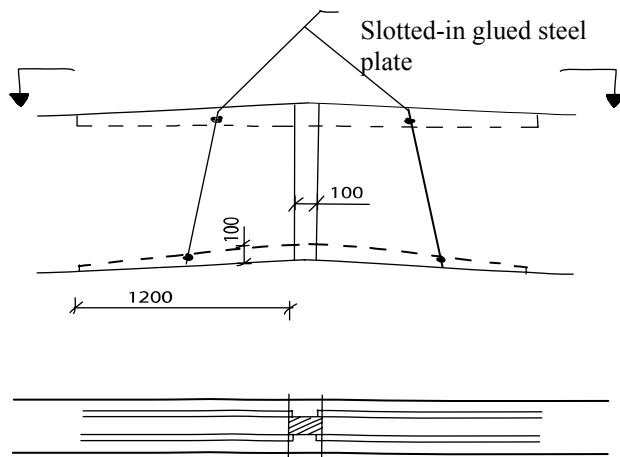
Figure 122-2: Glued connection at the ridge, using slotted-in steel plates.

In 2002, anchorage failure occurred in the glued joint.

The investigation revealed that the glued joint was not appropriate for this structure. Moisture induced deformations are not allowed due to the restraining effect of the glued-in steel plates. Moreover, the quality of the glue line was bad.

This failure is caused by a combination of disregard of environmental actions (restrained shrinkage) and poor principles during erection (poor quality of bond line).
