Performance and wear mechanisms of novel superhard diamond and boron nitride based tools in machining AI-SiCp metal matrix composite

Published in: Wear

Performance and wear mechanisms of novel superhard diamond and boron nitride based tools in machining Al-SiCp metal matrix composite

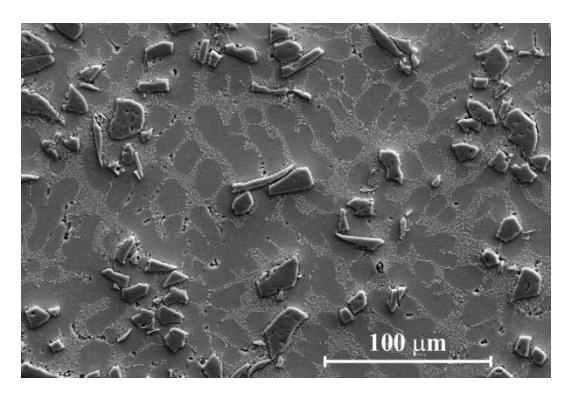
Fig. 1. Scanning electron microscope (SEM) image of the microstructure of Al-SiC_p MMC workpiece material.

The following metal matrix composite (MMC) material was used in experiments – AlSi9Mg0.3 aluminum alloy reinforced with SiC particles (20% vol.) having the grain-size of 10 to 30 μ m. The molten Al-SiC_p MMC material was gravity cast (directly from the industrial furnace, Amtek Components Sweden AB) into tubular stainless steel moulds. The moulds were allowed to cool for 30 seconds on air and then rapidly cooled in a water basin. This sequence was found to minimize the sinking of SiC particles and provide the MMC microstructure identical to the industrial one (see Fig. 1). Cast MMC ingots were pre-machined to bars of 56 mm in diameter and 400 mm in length prior to the actual machining tests.

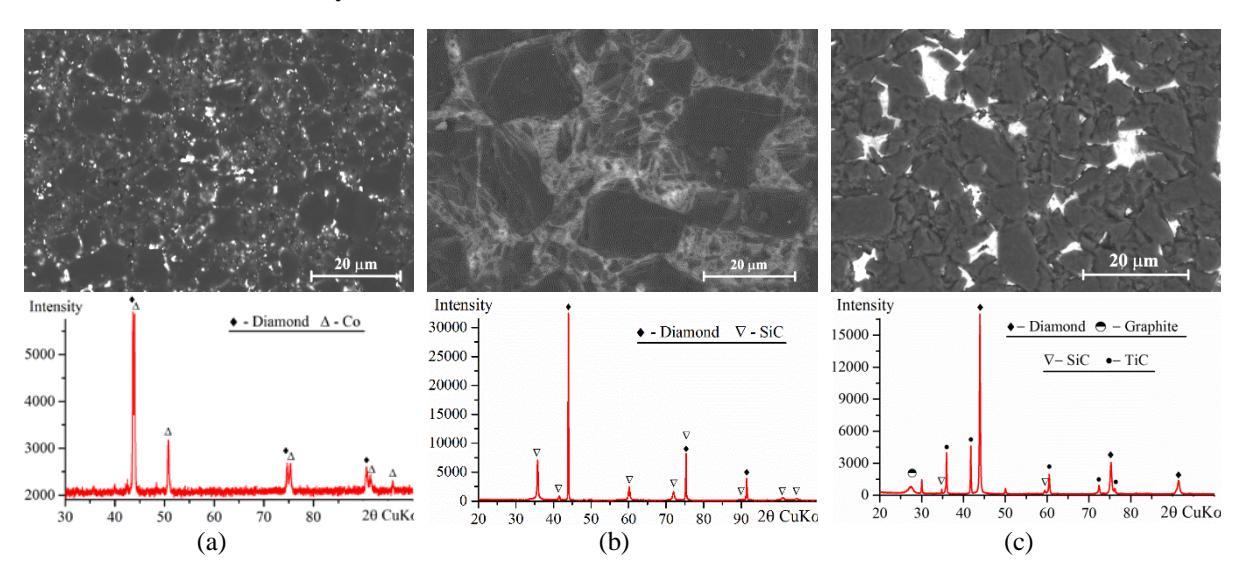
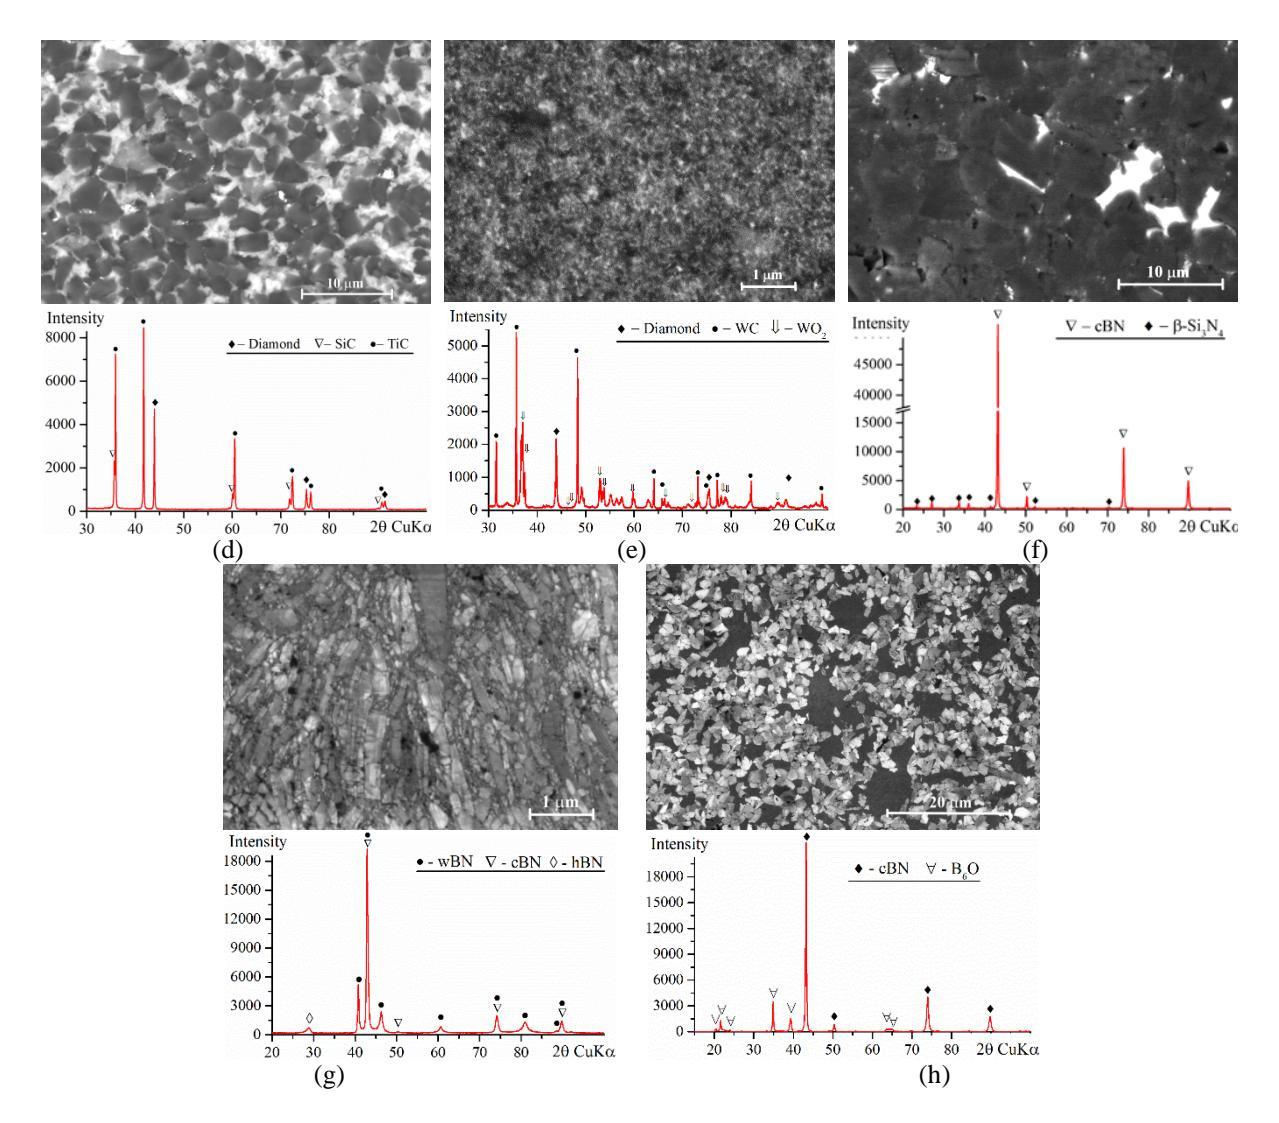
Fig. 2. SEM images of the microstructure and corresponding XRD pattern for tool materials: (a) D-Co, (b) D-SiC, (c) D-MAX₉₅, (d) D-MAX₆₀, (e) nD-nWC, (f) bcBN, (g) wBN-cBN, (h) B₆O-cBN.

1. D-Co – commercial polycrystalline diamond material which forms a solid diamond matrix as a result of intergrowth of diamond grains. The formation of strong diamond-to-diamond bonding is a result of dissolution-precipitation sintering mechanism when molten cobalt dissolves part of the diamond grain to the solubility limit of carbon in the Co-C solution and precipitates it as diamond on the diamond grains (Fig. 2.a). The material possesses high hardness of HV = 89 GPa (Fig. 3), high fracture toughness ($K_{IC} = 9.8$ MPa·m^{1/2}) and thermal conductivity of k = 760 W/(m·K) [3].

- 2. D-SiC thermostable polycrystalline composite which forms as a result of infiltration of molten silicon into the diamond preform and subsequent reaction of both phases with formation of silicon carbide matrix (Fig. 2.b). The material has hardness of HV = 84 GPa (Fig. 3), lower toughness of $K_{IC} = 7.6$ MPa·m^{1/2} and lower thermal conductivity of $k \approx 200$ W/(m·K) [8].

- 3. D-MAX₉₅ experimental polycrystalline diamond material where the bonding of diamond is realized via decomposition of Ti_3SiC_2 MAX-phase during the sintering, release of TiC, elemental silicon and titanium and their subsequent reaction with the diamond [9]. Mixture of 95 vol.% diamond and 5 vol.% Ti_3SiC_2 was subjected to the sintering process (Fig. 2.c). The sintering resulted in a material with hardness of HV = 71 GPa (Fig. 3).

- 4. D-MAX₆₀ similar experimental polycrystalline diamond material which contained 60 vol.% diamond and 40 vol.% Ti₃SiC₂ prior to the sintering (Fig. 2.d). Reduced diamond contents, compared to D-MAX₉₅, resulted in a lower hardness of HV = 62 GPa (Fig. 3).

- 5. nD-nWC experimental material for which the nano-diamond (3-15 nm) is subjected to sintering with tungsten [10], the reaction products creating a nano-grained WC matrix (Fig. 2.e). Residual surface oxygen introduces an undesired by-product of WO₂. Softer WC matrix and presence of WO₂ cause a reduced hardness of HV = 52 GPa (Fig. 3).

- 6. bcBN experimental binderless cubic boron nitride material which possesses a solid cBN matrix as a result of diffusional bonding of cBN grains during the high temperature high pressure sintering (2300 °C and 8 GPa). Additive of 3 vol.% of silicon nitride (Fig. 2.f) is introduced to the cBN matrix for enhancement of fracture toughness (K_{IC} = 12.6 MPa·m^{1/2}) [11]. The material has highest hardness of HV = 54 GPa and thermal conductivity of k = 180 W/(m·K) [12] among the boron nitride based tooling.

- 7. wBN-cBN experimental superhard material which forms as a result of controlled partial transformation (50 vol.%) of ultra-fine grain wurtzite boron nitride to a cubic one in the region of thermodynamic stability of cBN at pressure 8 GPa and temperature of 1700 °C (Fig. 2.g). While the mechanical properties are rather high (Fig. 3), its thermal conductivity is only k = 26 W/(m·K) [13].

- 8. B₆O-cBN experimental superhard material which combines superhard cBN grains bound in a superhard matrix of boron sub-oxide B₆O. The mixture of 40 vol. % B₆O and 60 vol.% cBN were sintered at pressure 8 GPa and temperature of 2000 °C (Fig. 2.h) [14]. High hardness of the material is combined with rather low fracture toughness (K_{IC} = 4.7 MPa·m^{1/2}) and low thermal conductivity of k = 14 W/(m·K) [14].

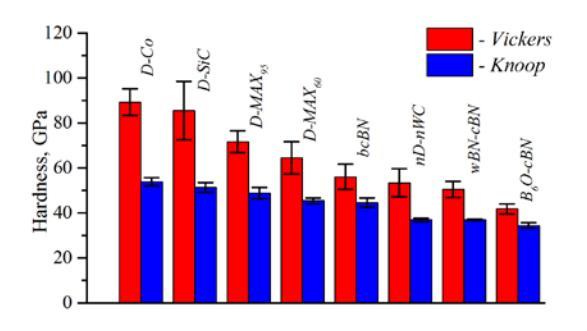
Fig. 3. Vickers and Knoop hardness of the tool materials.

Cutting forces were continuously recorded with Kistler 9129AA dynamometer, while tool wear and surface roughness were regularly inspected after 500 – 600 meters of machining. Leica MZ16 stereomicroscope was used for the measurement of flank wear *VB*, while Alicona InfiniteFocus 3D optical microscope was used for 3D analysis of worn tools. LEO/Zeiss 1560 high resolution scanning electron microscope (SEM) was used for the detailed inspection of the tool and workpiece material microstructure, worn tools, machined surface and sub-surface. FEI NanoLab 600 dual beam microscope was used for lamella preparation using focused ion beam (FIB) lift-out technique [15]. JEOL 3000F transmission electron microscope (TEM) was used for imaging, selected area electron diffraction (SAED) and energy dispersive X-ray (EDX) analysis (SDD X-Maxⁿ EDX system, Oxford Instruments). XRD analysis of tool materials was done on STOE Darmstadt diffractometer with CuKα source. Hardness of the tool materials was measured with Vickers and Knoop indenters at load 4.9 N (see Fig. 3) on Ernst Leitz Wetzlar microhardness tester.

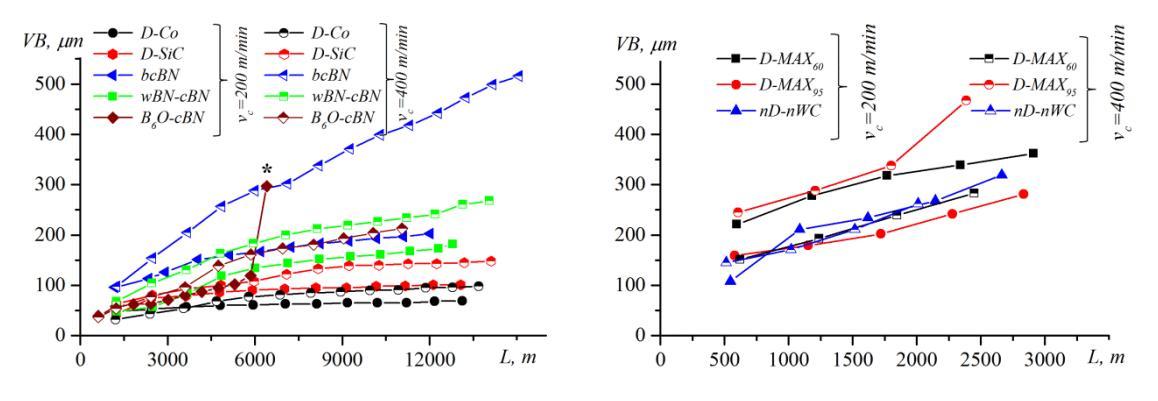
Fig. 4 shows the development of the flank wear VB for all tool materials at both cutting speeds employed. Based on the results of the tests, the materials can be grouped into high- and low-performance ones. Fig. 4.b shows that both diamond-based materials with MAX-phase binders and the nano-diamond tooling reached the tool life criterion of $VB = 300 \,\mu\text{m}$ within the first 2500 - 3000 meters of tool engagement. All other tool materials (Fig. 4.a) were tested for the engagement of 14 000 meters. It can be seen that the increase in the cutting speed from $v_c = 200 \,\text{m/min}$ to 400 m/min results in the increases of the tool wear is attributed to the increased cutting speed.

Fig. 4. Tool wear development when machining with (a) high performance and (b) low performance tooling.

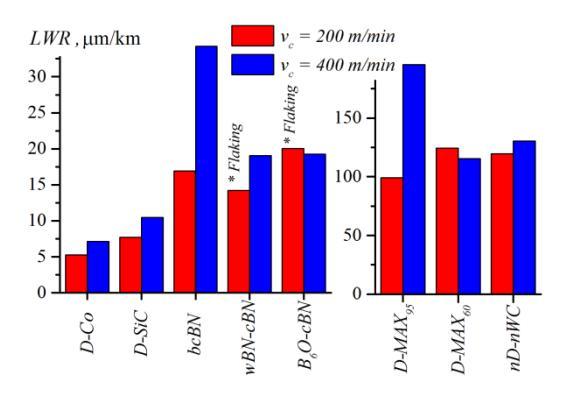
Fig. 5 presents the tests results in terms of linear wear rate (*LWR*, $\mu m/km$), defined as the ratio of the tool wear to the engagement distance measured within the normal wear region. It shows that D-Co material, the hardest among the tested (Fig. 3), possesses the highest wear resistance. The same relation is observed for D-SiC tool material that is the second hardest (Fig. 3), which follows the trend typical for abrasive wear. However the other diamond based materials have extremely low wear resistance due to, as shown later, intensive adhesive wear. The expected relation between the tool material hardness and the wear resistance was not directly followed for cBN-based materials either. wBN-cBN and B₆O-cBN tools showed lower linear wear rates at $v_c = 400$ m/min than that harder binderless cBN tool grade. This is related to the stable adhesion of the tool against the abrasion of the incoming SiC particles. Even more intensive adhesion of the tool surfaces for wBN-cBN and B₆O-cBN at lower cutting speed of $v_c = 200$ m/min (Fig. 22.b) resulted in flaking and chipping on the tool rake as indicated on Fig. 5.

Fig. 5. Linear wear rate (LWR) for different tool materials.

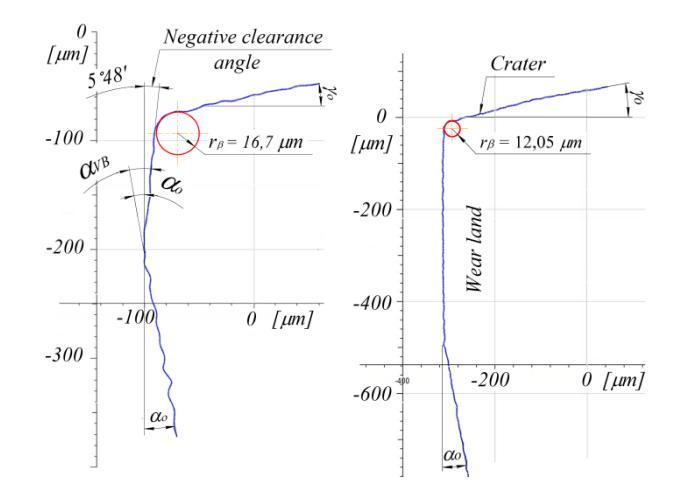
Subsequent analysis of the worn tools with the help of 3D microscopy has revealed that flank and crater wear do not completely characterize the wear topography. The original edge radius of $r_{\beta} = 15 \,\mu\text{m}$, identical for all tools, changed in the course of tool wear, as illustrated on Fig. 7. Apart from the edge radius, clearance angle α_{VB} (Fig. 7.a) was also found to deviate from its nominal value, which for the given insert and toolholder geometry should equal $\alpha_o = 9.7$ deg. [16]. Fig. 7 shows that a negative clearance angle is forming on the D-SiC tool, while bcBN grade attains the theoretical value.

Fig. 7. Cross-sectional data for the worn (a) D-SiC and (b) bcBN tools ($v_c = 400 \text{ m/min}$).

Another, more conventional, mechanism of tool material softening at high cutting speed and related high tool temperature is often attributed to the abrasive tool wear. This mechanism is often observed for cemented carbide tools which exhibit strong loss of hardness at elevated temperature. However in case of superhard tooling the situation is not as pronounced. Chou and Liu [21] have shown that machining Al-SiCp composite at cutting speed of 180 m/min results in the maximum temperature of 410 °C on the tool. The room temperature hardness (Fig. 3) of cBN-based tool materials decreases significantly and in this range of cutting temperature attains values of $HV \approx 22$ GPa for bcBN [22] and $HV \approx 20$ GPa for wBN-cBN [23] materials. Therefore SiC particles in the MMC having slightly higher hardness (HV = 25-27 GPa) [24] can inflict mild abrasive wear to the cBN-based tooling. In the case of diamond, its hardness reduces only to $HV \approx 84$ GPa for the given process temperature [24] and thus abrasion by the much softer SiC is very unlikely. On the other hand, the chemical wear of diamond tooling, which results in nano-structured SiC (Fig. 19), enables abrasive wear since the formed SiC is softer than diamond. Therefore chemical wear followed by abrasion of its reaction products is likely to be one of the primary wear mechanisms for diamond tooling. The kinetics of the chemical reaction is linearly proportional to the process temperature. In this case, temperature gradients along the flank wear land, with the highest temperature at the edgeline, would imply the intensity of SiC formation to decrease from the tool edge towards the end of VB, thus explaining negative clearance α_{VB} found only on diamond tooling (Fig. 7.a and Fig 8.a).

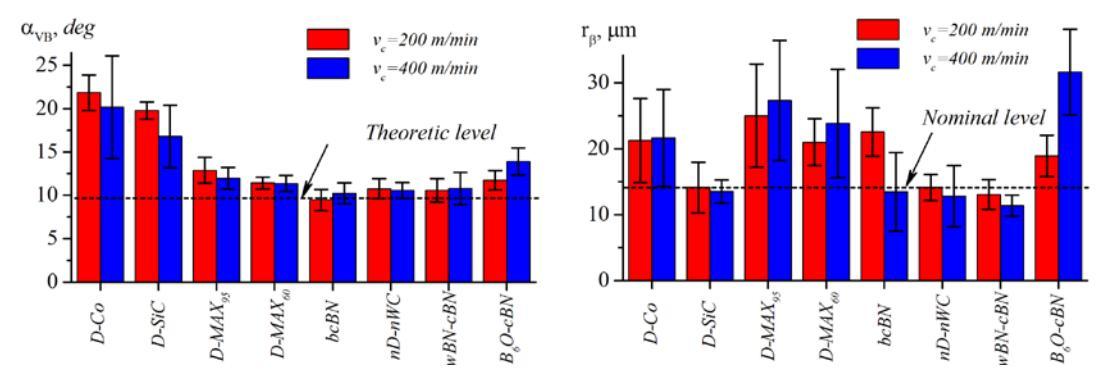
Fig. 8 summarizes the results of the measurement of edge radius r_{β} and clearance angle α_{VB} for different tool materials and test conditions. It shows that D-Co and D-SiC materials, which have the highest performance, form a highly negative clearance angle. This negative clearance angle is observed on the

etched tools, while the same measurement done prior to the etching indicates that the angle is on the level of the nominal one. This indicates that the workpiece material layer is adhering to the tool flank of D-Co and D-SiC tool and also acts as the tool protection layer (TPL) against the abrasion by SiC particles, which is also discussed later in the article. For other tooling materials the TPL was observed only on the rake.

Fig. 8. Measurement results of (a) clearance angle and (b) edge radius for worn tools.

Fig. 17.a shows that *K* value, and thus the wear resistance of the tool material, initially decreases and eventually approaches some asymptotic value upon longer tool engagement. The tool run-in and stabilization of TPL are related to this initial period. Fig. 17.b presents the average value of *K* over the entire cutting process. This value characterizes the tribologic wear conditions, irrespectively of the hardness of the tool material H_{tool} , and therefore can be used for judgement of the wear process itself. For example D-Co and B₆O-cBN tool materials have similar *K* value for tests at $v_c = 400$ m/min and in both cases the edge radius r_{β} (Fig. 8.b) for the worn tools and the dimensions of TPL are similar too.

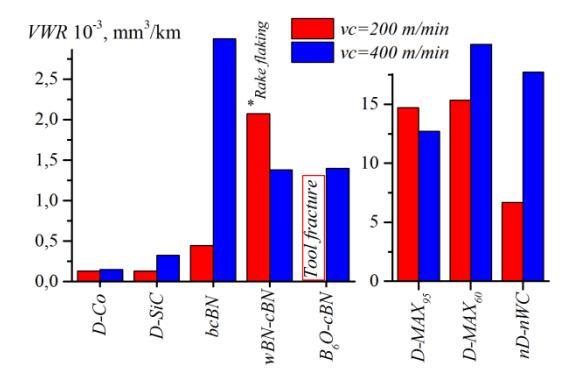
Formation of the negative clearance angle and presence of crater wear for several grades indicate that both the flank wear *VB* and linear wear rate *LWR* do not completely characterize the intensity of the wear process and that the volumetric changes should be accounted for. Volume difference measurement (*VDM*) module of the 3D microscope was used for such analysis. The *VDM* method calculates the difference between the surfaces of new and worn tool in the same location as exemplified for bcBN tool in Fig. 6. Fig. 9 summarizes the calculated results of the volumetric wear rate (*VWR*, mm^3/km) determined with the use of *VDM* method. It can be seen that diamond tool materials with MAX-phase binder have high wear rate which has minor dependence on the cutting speed. This is related to the adhesive pluck out of the diamond grains and binder (see Fig. 10.a) due to poor binding between these phases. For other materials the wear surfaces have smoothened appearance with apparent scratches due to abrasive wear, as exemplified for the D-SiC tooling shown on Fig. 10.b. Fig. 10.b also shows that diamond phase attained minimal abrasive damage while the softer SiC binder has been preferentially abraded from the tool rake.

Fig. 9. Volumetric wear rate (VWR) for different tool materials.

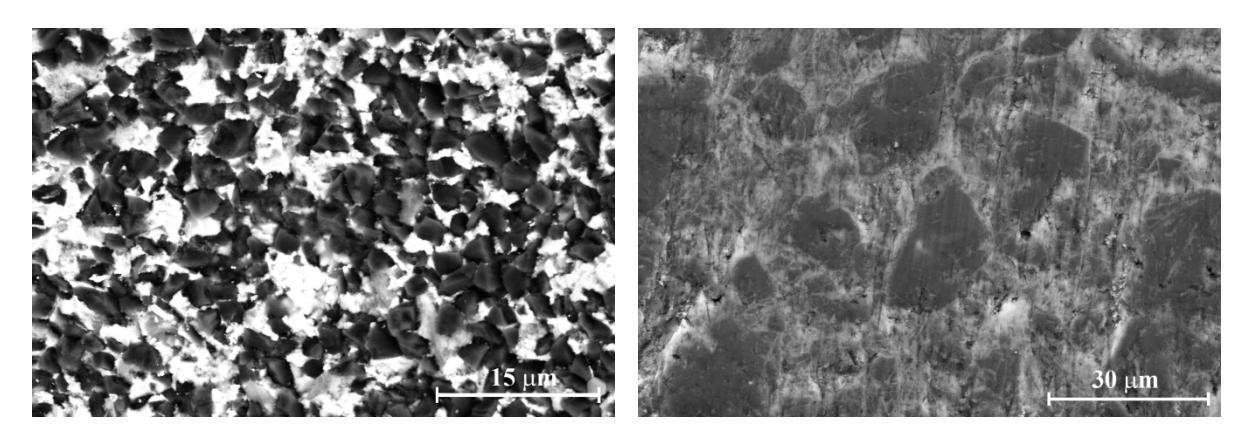
Fig. 10. SEM images of non-etched worn rake surface for (a) D-MAX₆₀ and (b) D-SiC at $v_c = 200$ m/min.
